GEOTECHNICAL INVESTIGATION FOR THE PROPOSED WAIANIWANIWA WATER STORAGE DAM

Prepared for
Central Plains Water Enhancement Committee
Selwyn District Council and Christchurch City Council
c/- Private Bag 1
Leeston

11 October 2002

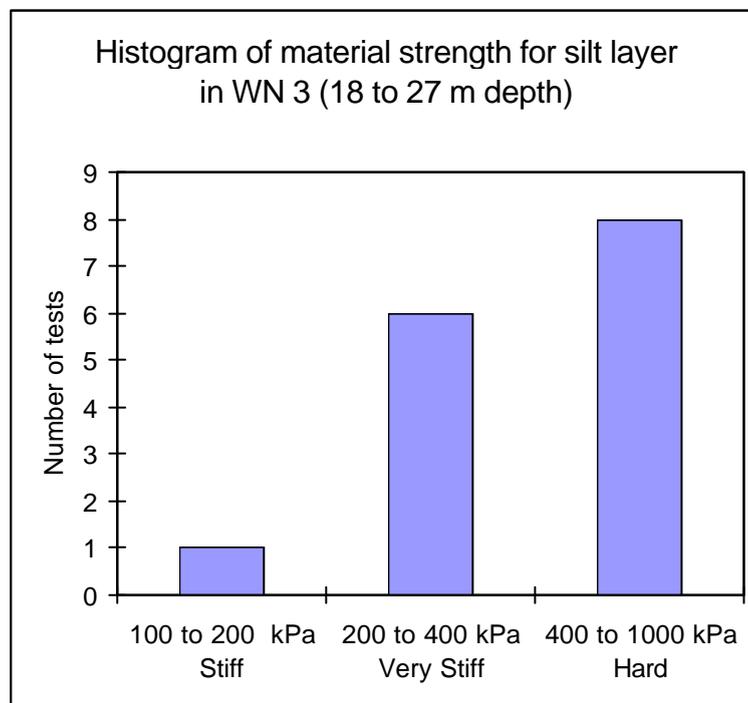
Figure 8
Pocket penetrometer results for silt layer in WN 3

Between 17 and 18 m depth, volcanic clasts were noted within the gravels. Between 18 and 27 m depth grey very stiff silt and very fine sand was encountered. This was laminated in part with typical lamination thickness of less than a few mm. Pocket penetrometer strength measurements were undertaken with most results falling in the range of very stiff to hard (Figure 8). Between 27 m and 38 m depth further gravels

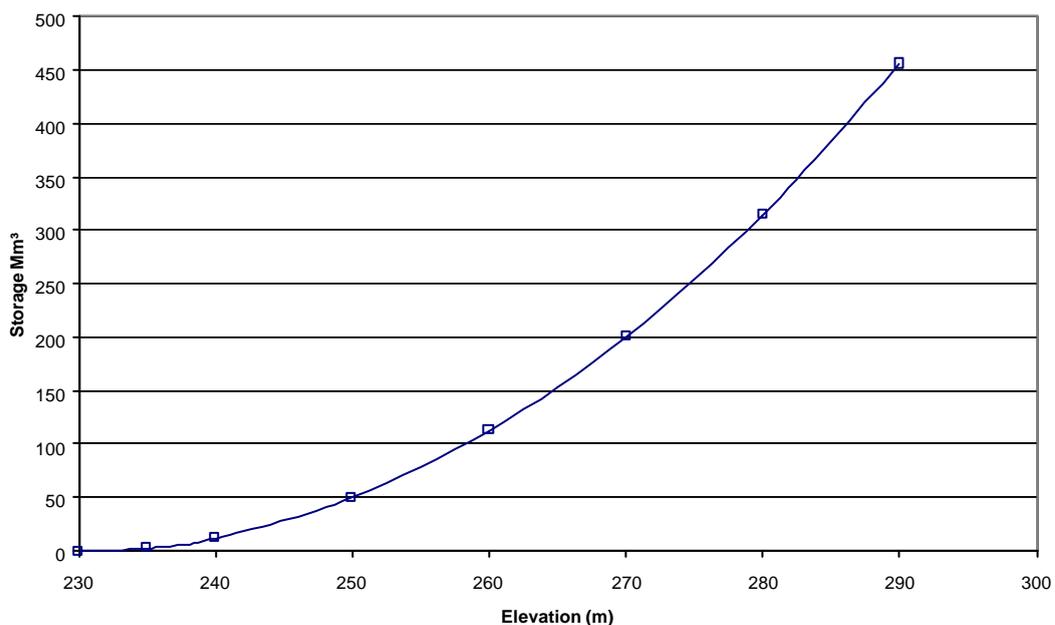
Figure 10
Storage Volume Curve for Proposed Reservoir

The reservoir volume has been calculated from the DTM and indicates that 290 M m³ of storage will require a maximum water level of RL280 m which is significantly less than RL 291 m previously estimated. The storage curve is presented in Figure 10, and Figure 11 indicates the shape of the proposed reservoir when full.

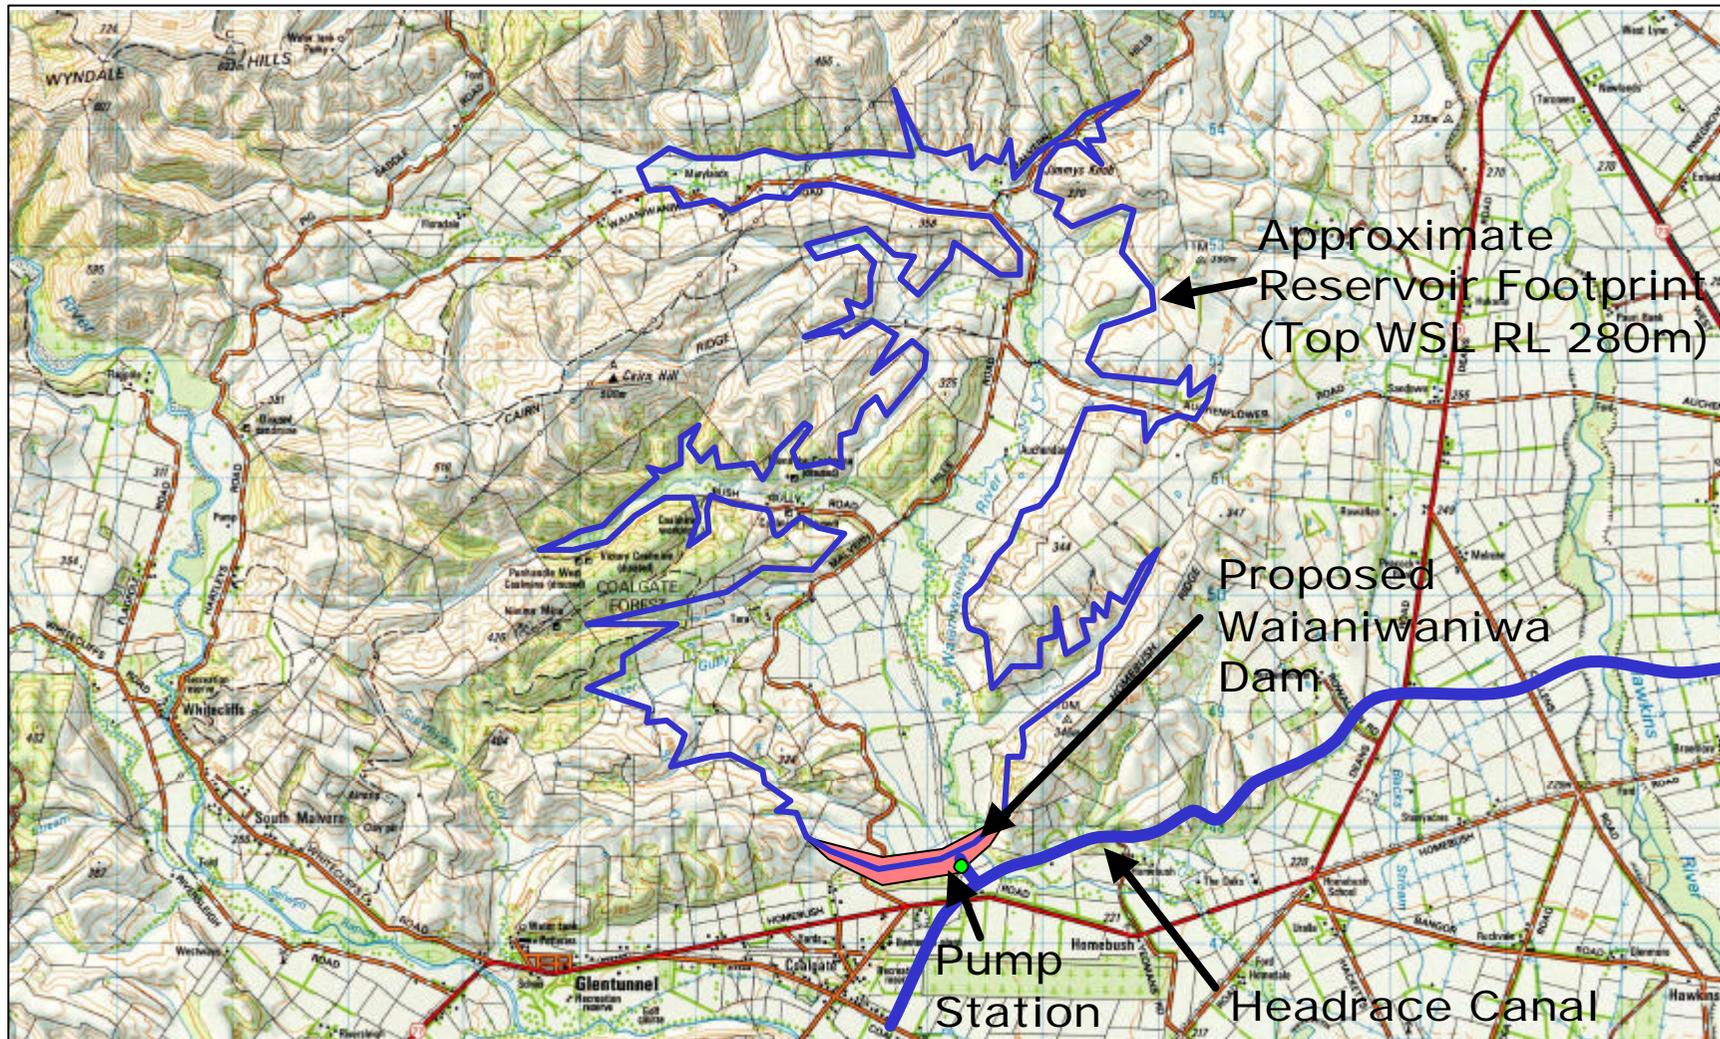
Figure 1

Layout of the proposed Waianiwaniwa storage dam, pump station and headrace canal

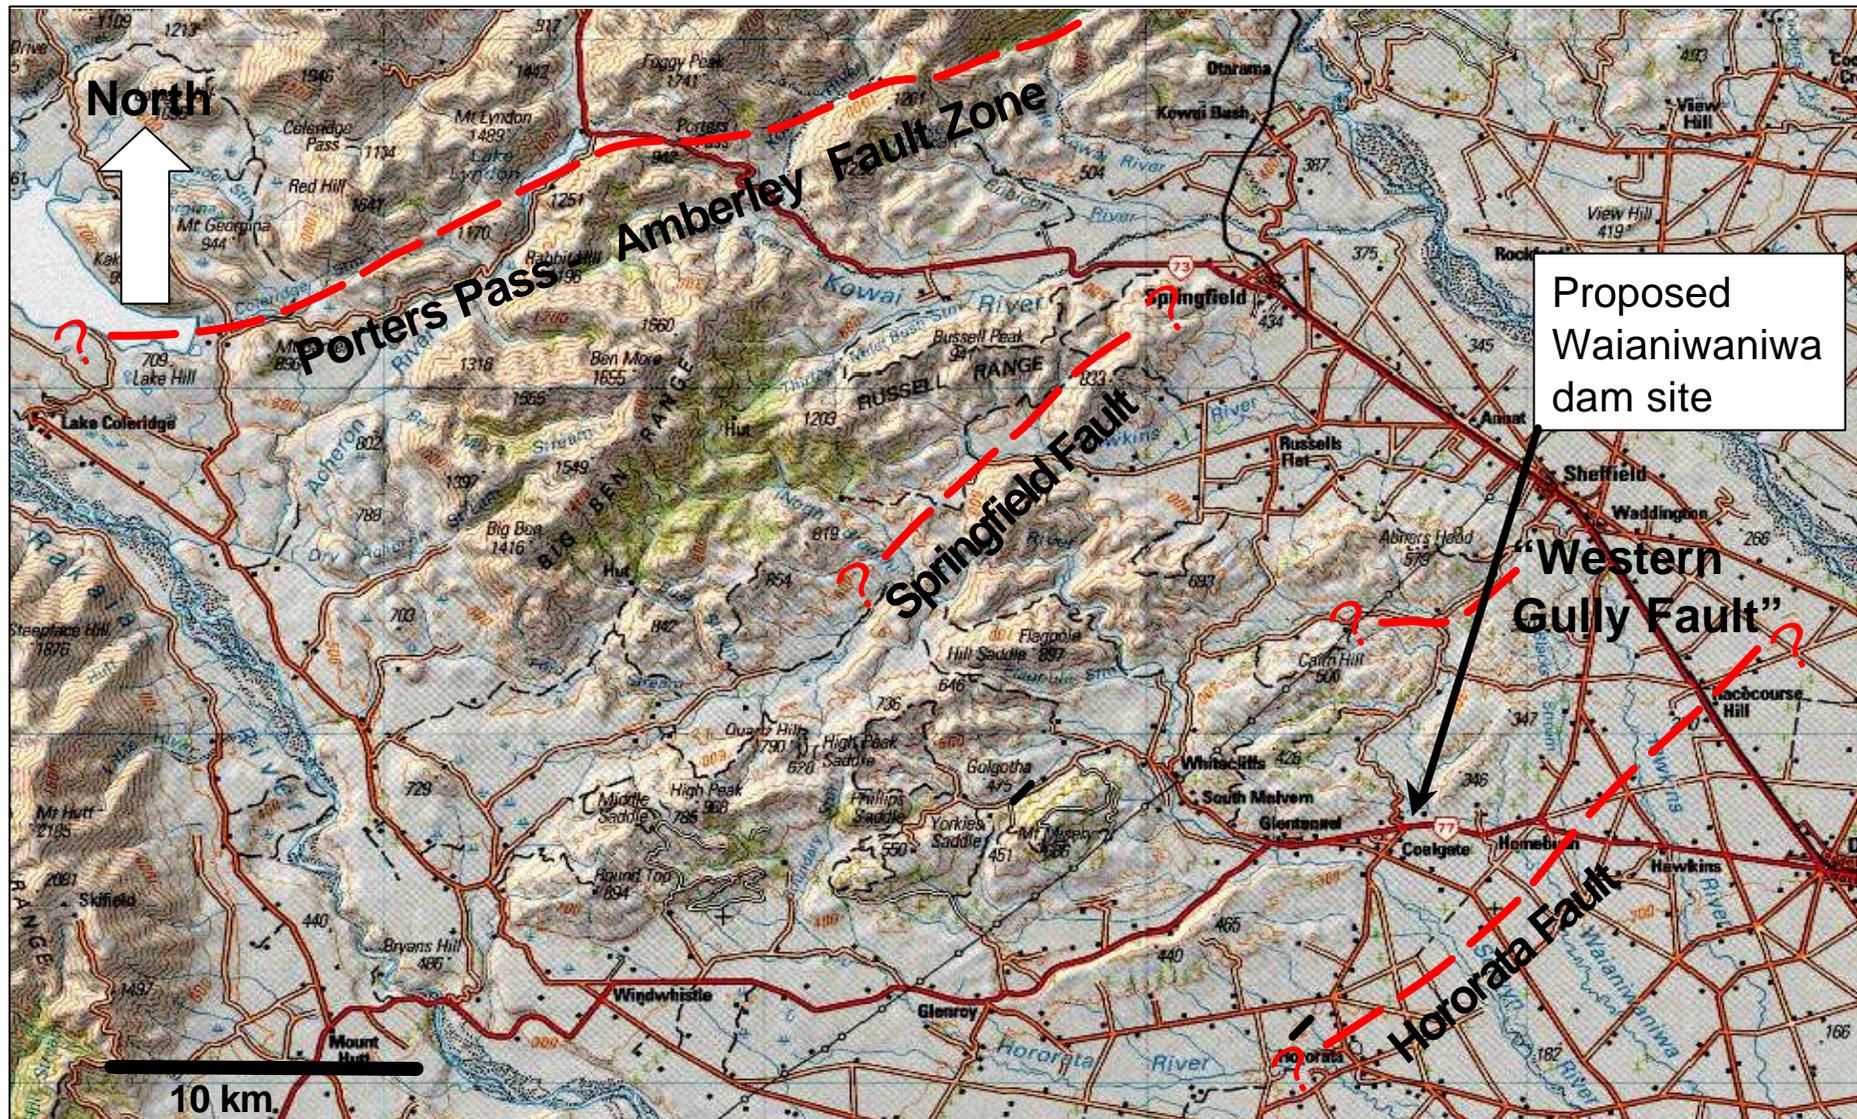
Figure 2

Map showing known active faults within 30 km of the proposed Waianiwaniwa dam site

Considerable research effort in New Zealand has been directed in the last decade to evaluating the hazard associated with geological structures capable of generating earthquakes (eg. Pettinga et al. 1998, Stirling et al., 1999, 2002). More than 20 active faults have been identified in Canterbury alone. Several of these structures pass within 30 km of the proposed dam site, as shown on Figure 2.

Speight (1928) inferred an east-west striking fault at the contact between a small outcrop of Tertiary sediments in the upper Waianiwaniwa Valley and adjacent Torlesse greywacke outcrop. A similar sliver of Tertiary rocks exists northwest of Mount Misery and this may also be a result of down faulting of the Tertiary block. No comprehensive active faulting study has been completed in this area, but it is likely that these faults have been active during the recent geological past. If these faults are indeed active, their shaking hazard to the proposed dam is expected to be similar to, or lower than, the known active faults shown in Figure 2.

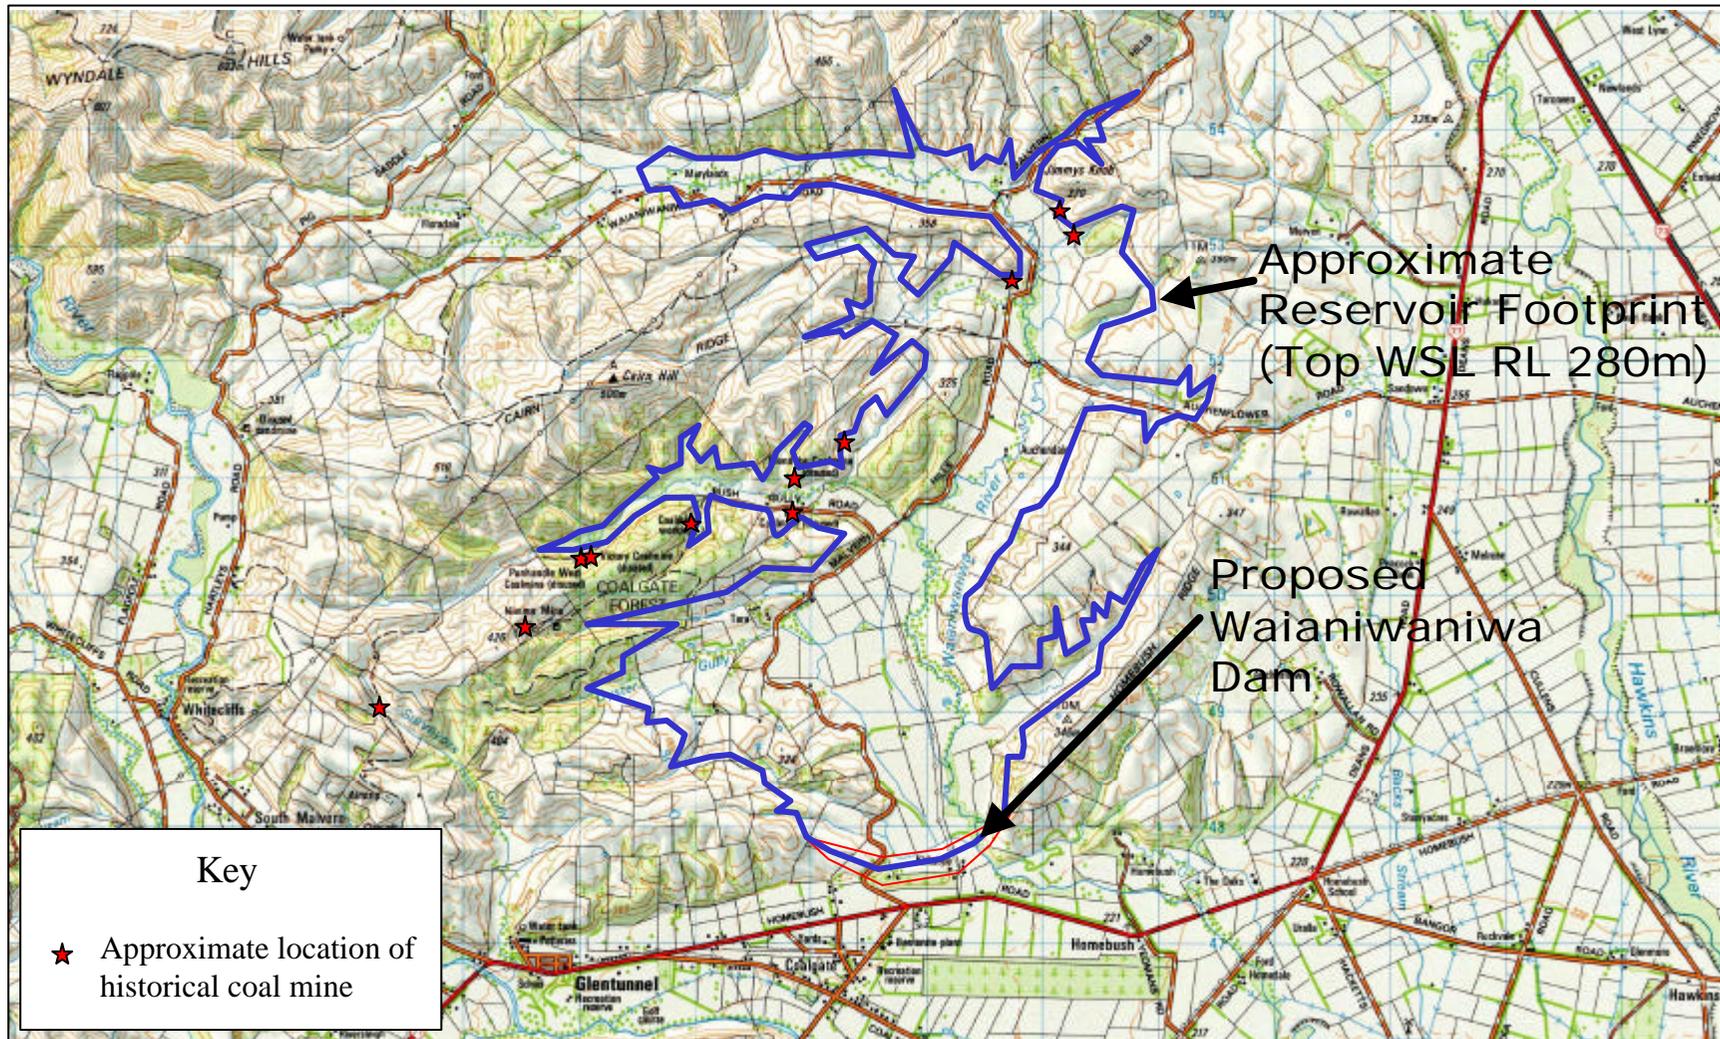
Figure 3

Plan showing the locations of known underground coal mines in the Waianiwaniwa Valley

Coal mines were operated in the Malvern Hills throughout the late 1800's and early 1900's. The majority of mines were located in Bush Gully and in Surveyors Gully, though other mines were located where coal seams were found to outcrop. Figure 4 shows the locations of coal mines throughout the Waianiwaniwa Valley. The underground mining was extensive in places, particularly in the case of the Klondyke mine, which followed seams up to "1500 feet down dip" (approximately 300 m below ground level), and up to about 600 m along strike (personal communication, Ken Shearer, Canterbury Coal Ltd). Klondyke Mine was unusually extensive, and many mines were discontinued because they were overwhelmed by groundwater or because the coal seams were faulted out. In some circumstances the coal seam was found again, and mining continued. The faults responsible for displacing the coal do not have large throws as the coal seams generally follow a line of strike, that is not radically offset.

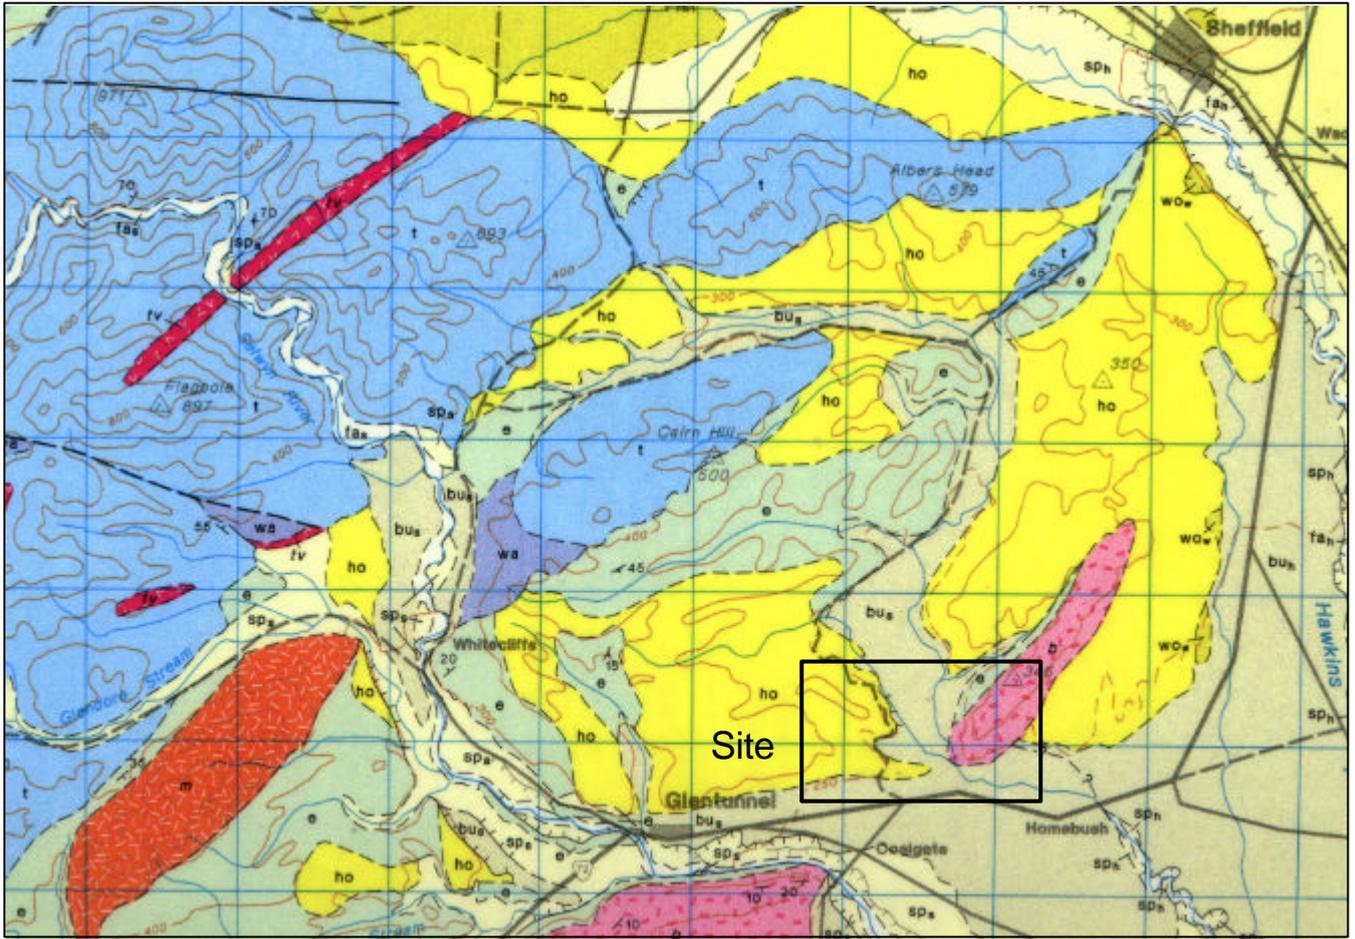
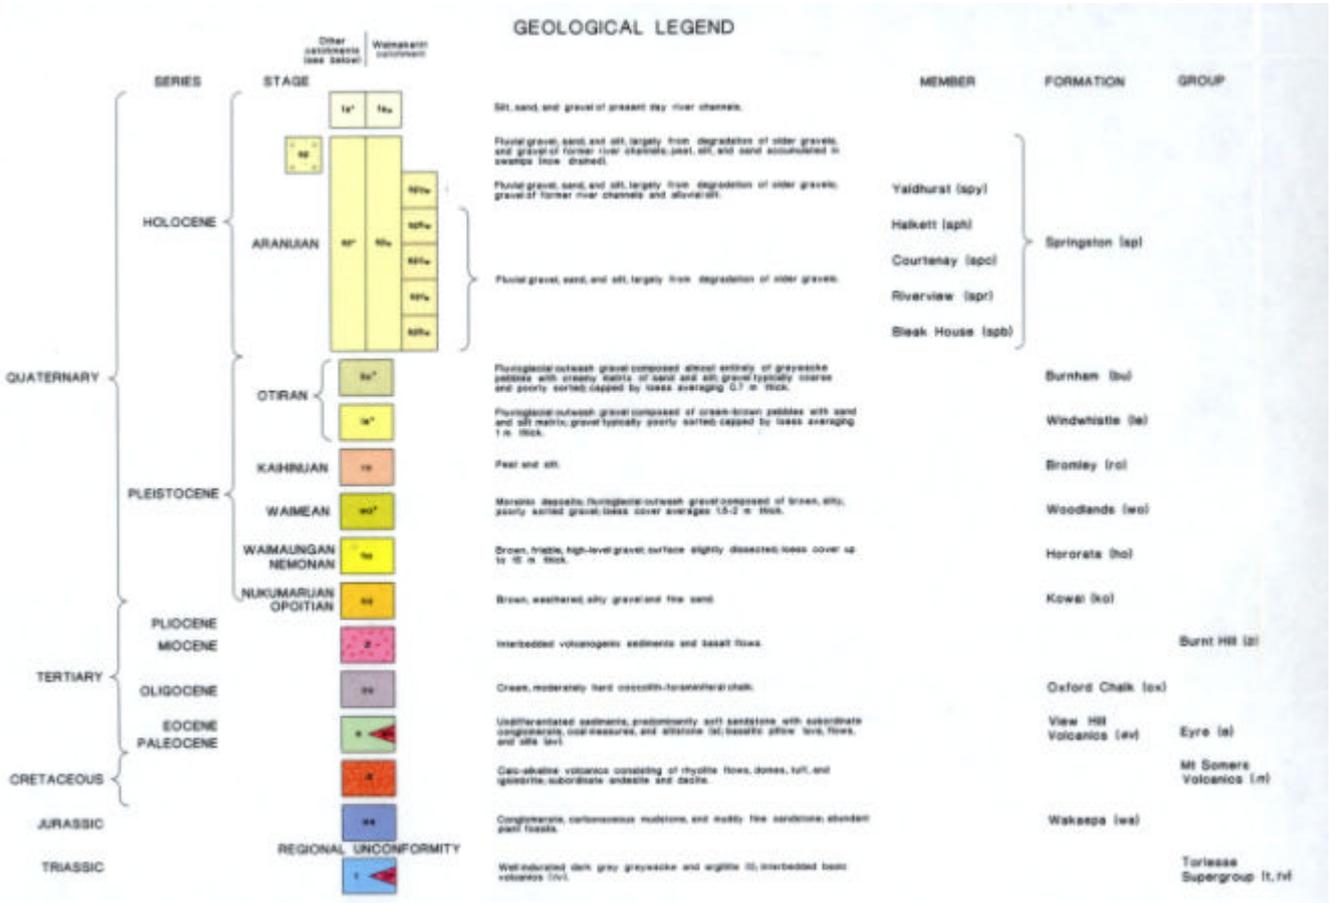
Figure 4

Geological map of Malvern Hills Area (after Wilson 1989)

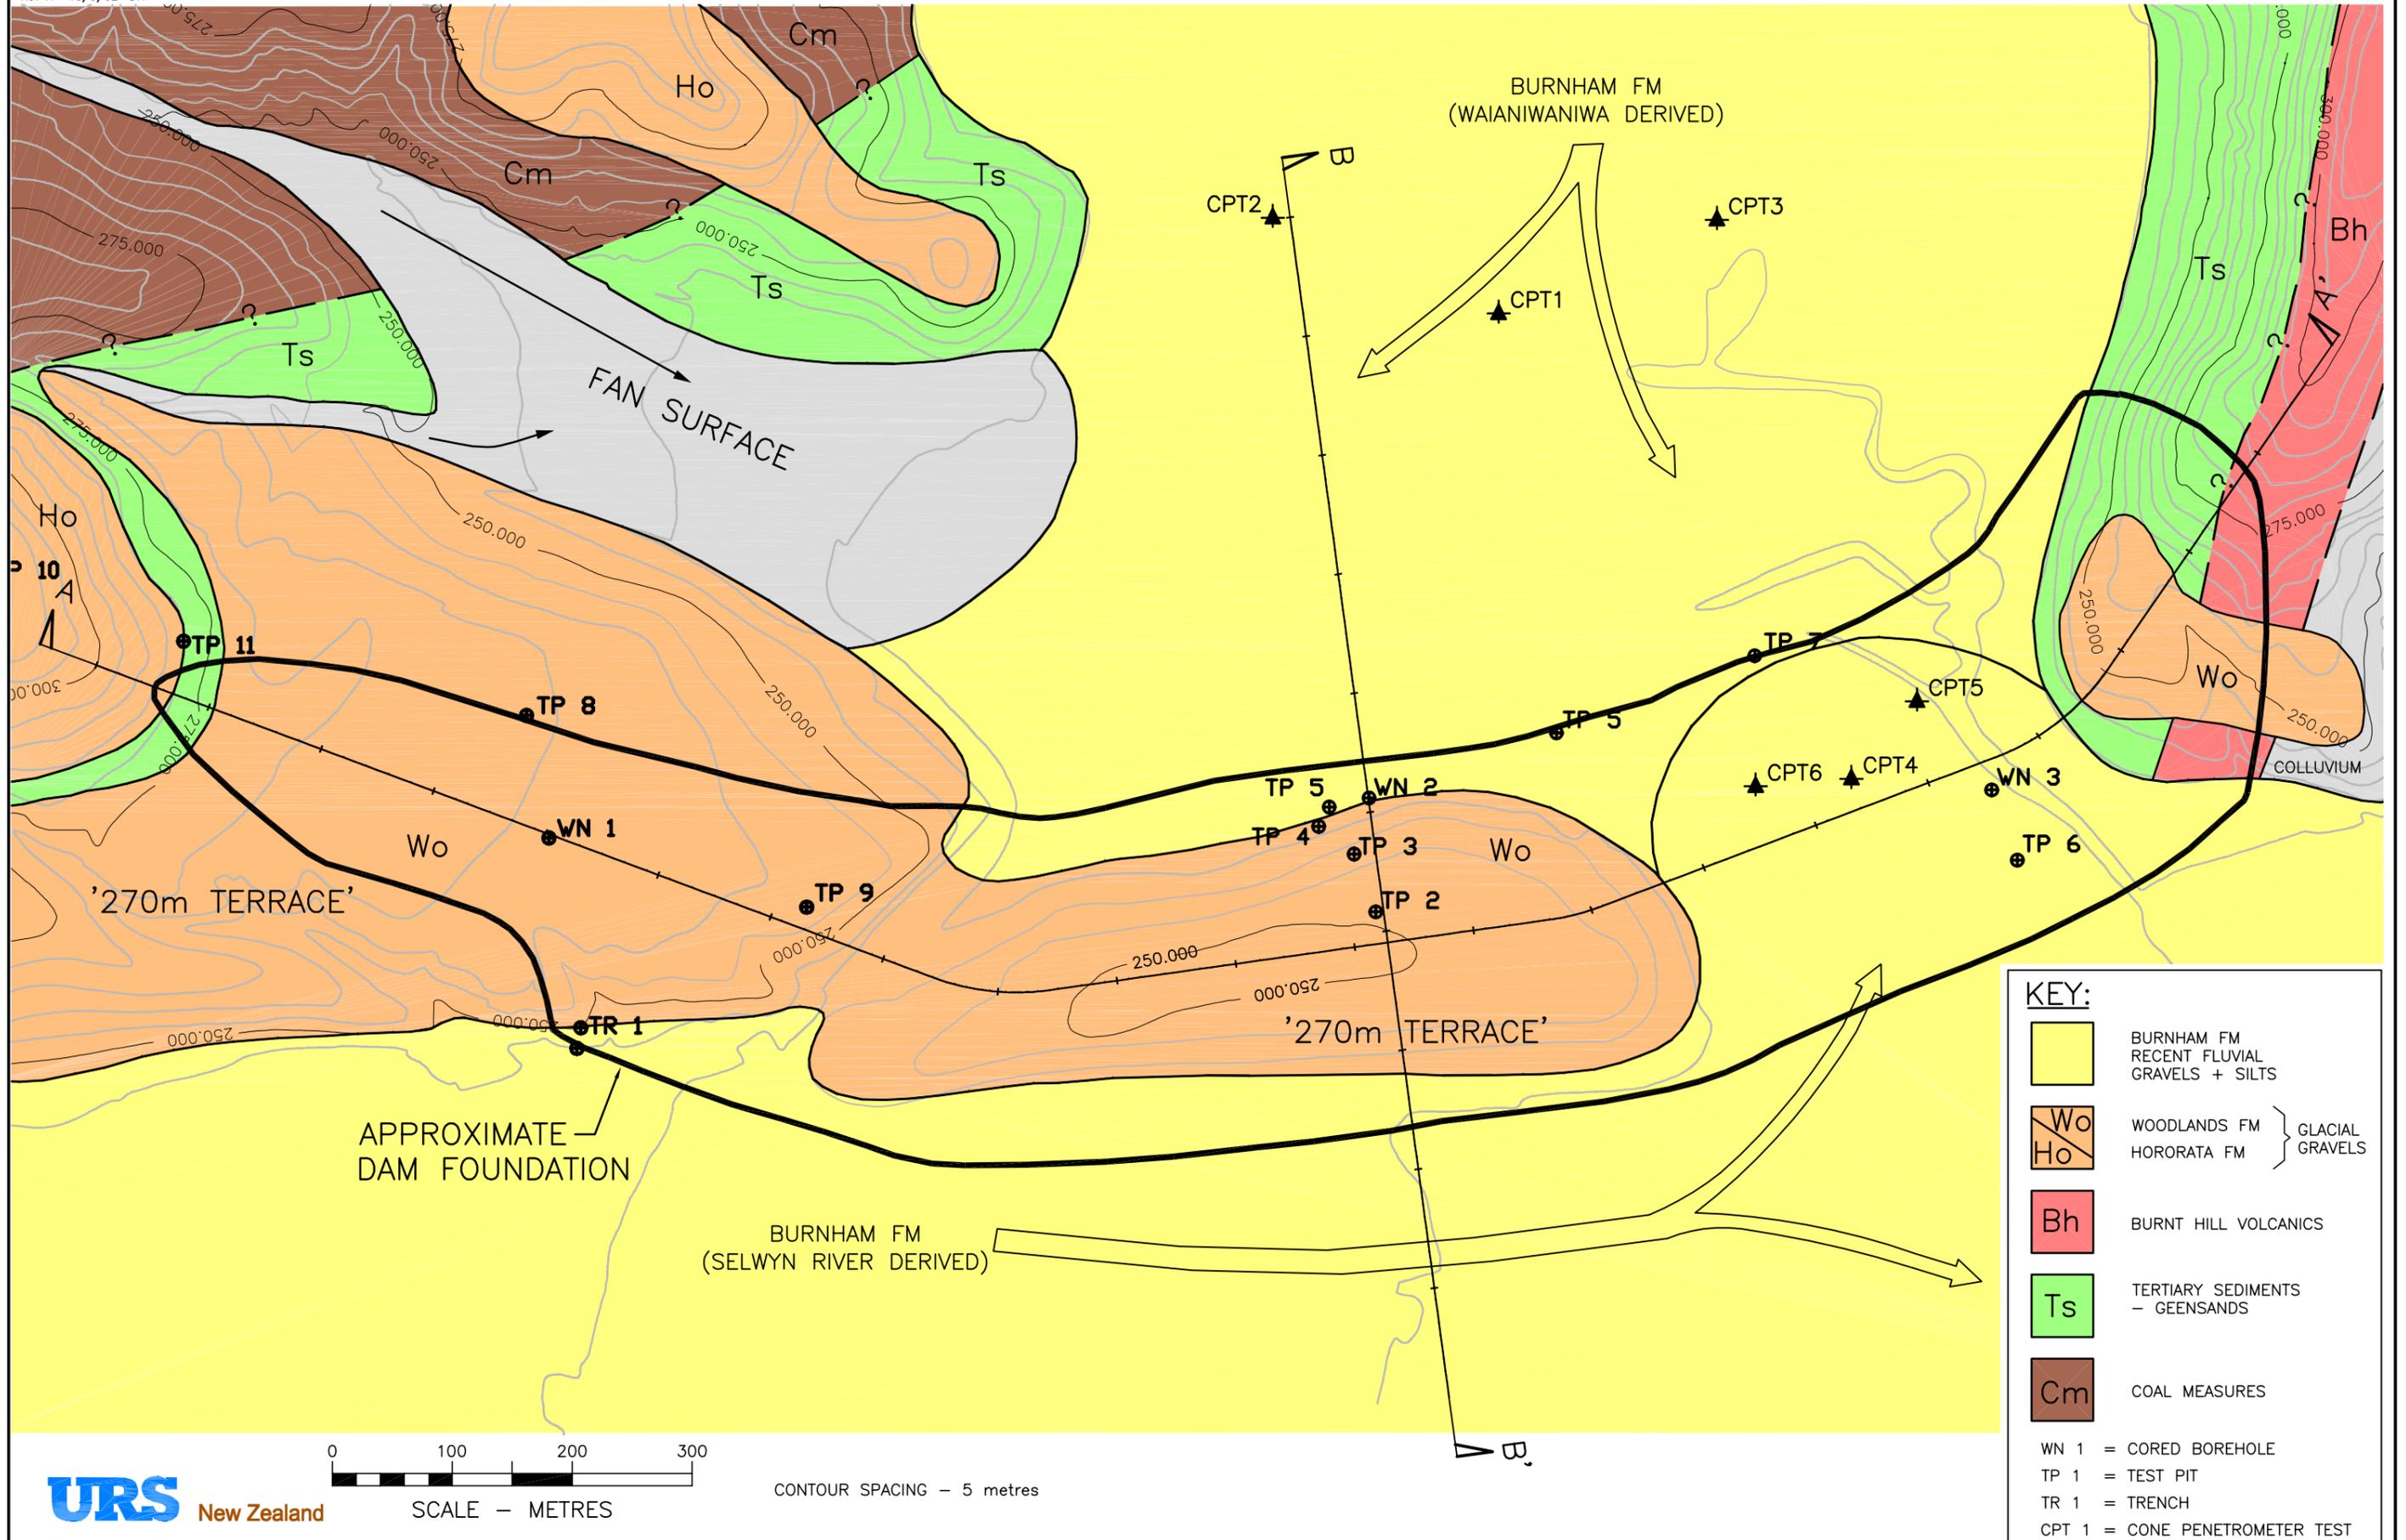
Figure No. 5

- BURNHAM FM
RECENT FLUVIAL
GRAVELS + SILTS
- Wo
 Ho } GLACIAL
WOODLANDS FM
HORORATA FM } GRAVELS
- Bh
BURNT HILL VOLCANICS
- Ts
TERTIARY SEDIMENTS
- GEENSANDS
- Cm
COAL MEASURES

INTERPRETED DAM SITE GEOLOGY AND LOCATION OF SUBSURFACE INVESTIGATIONS

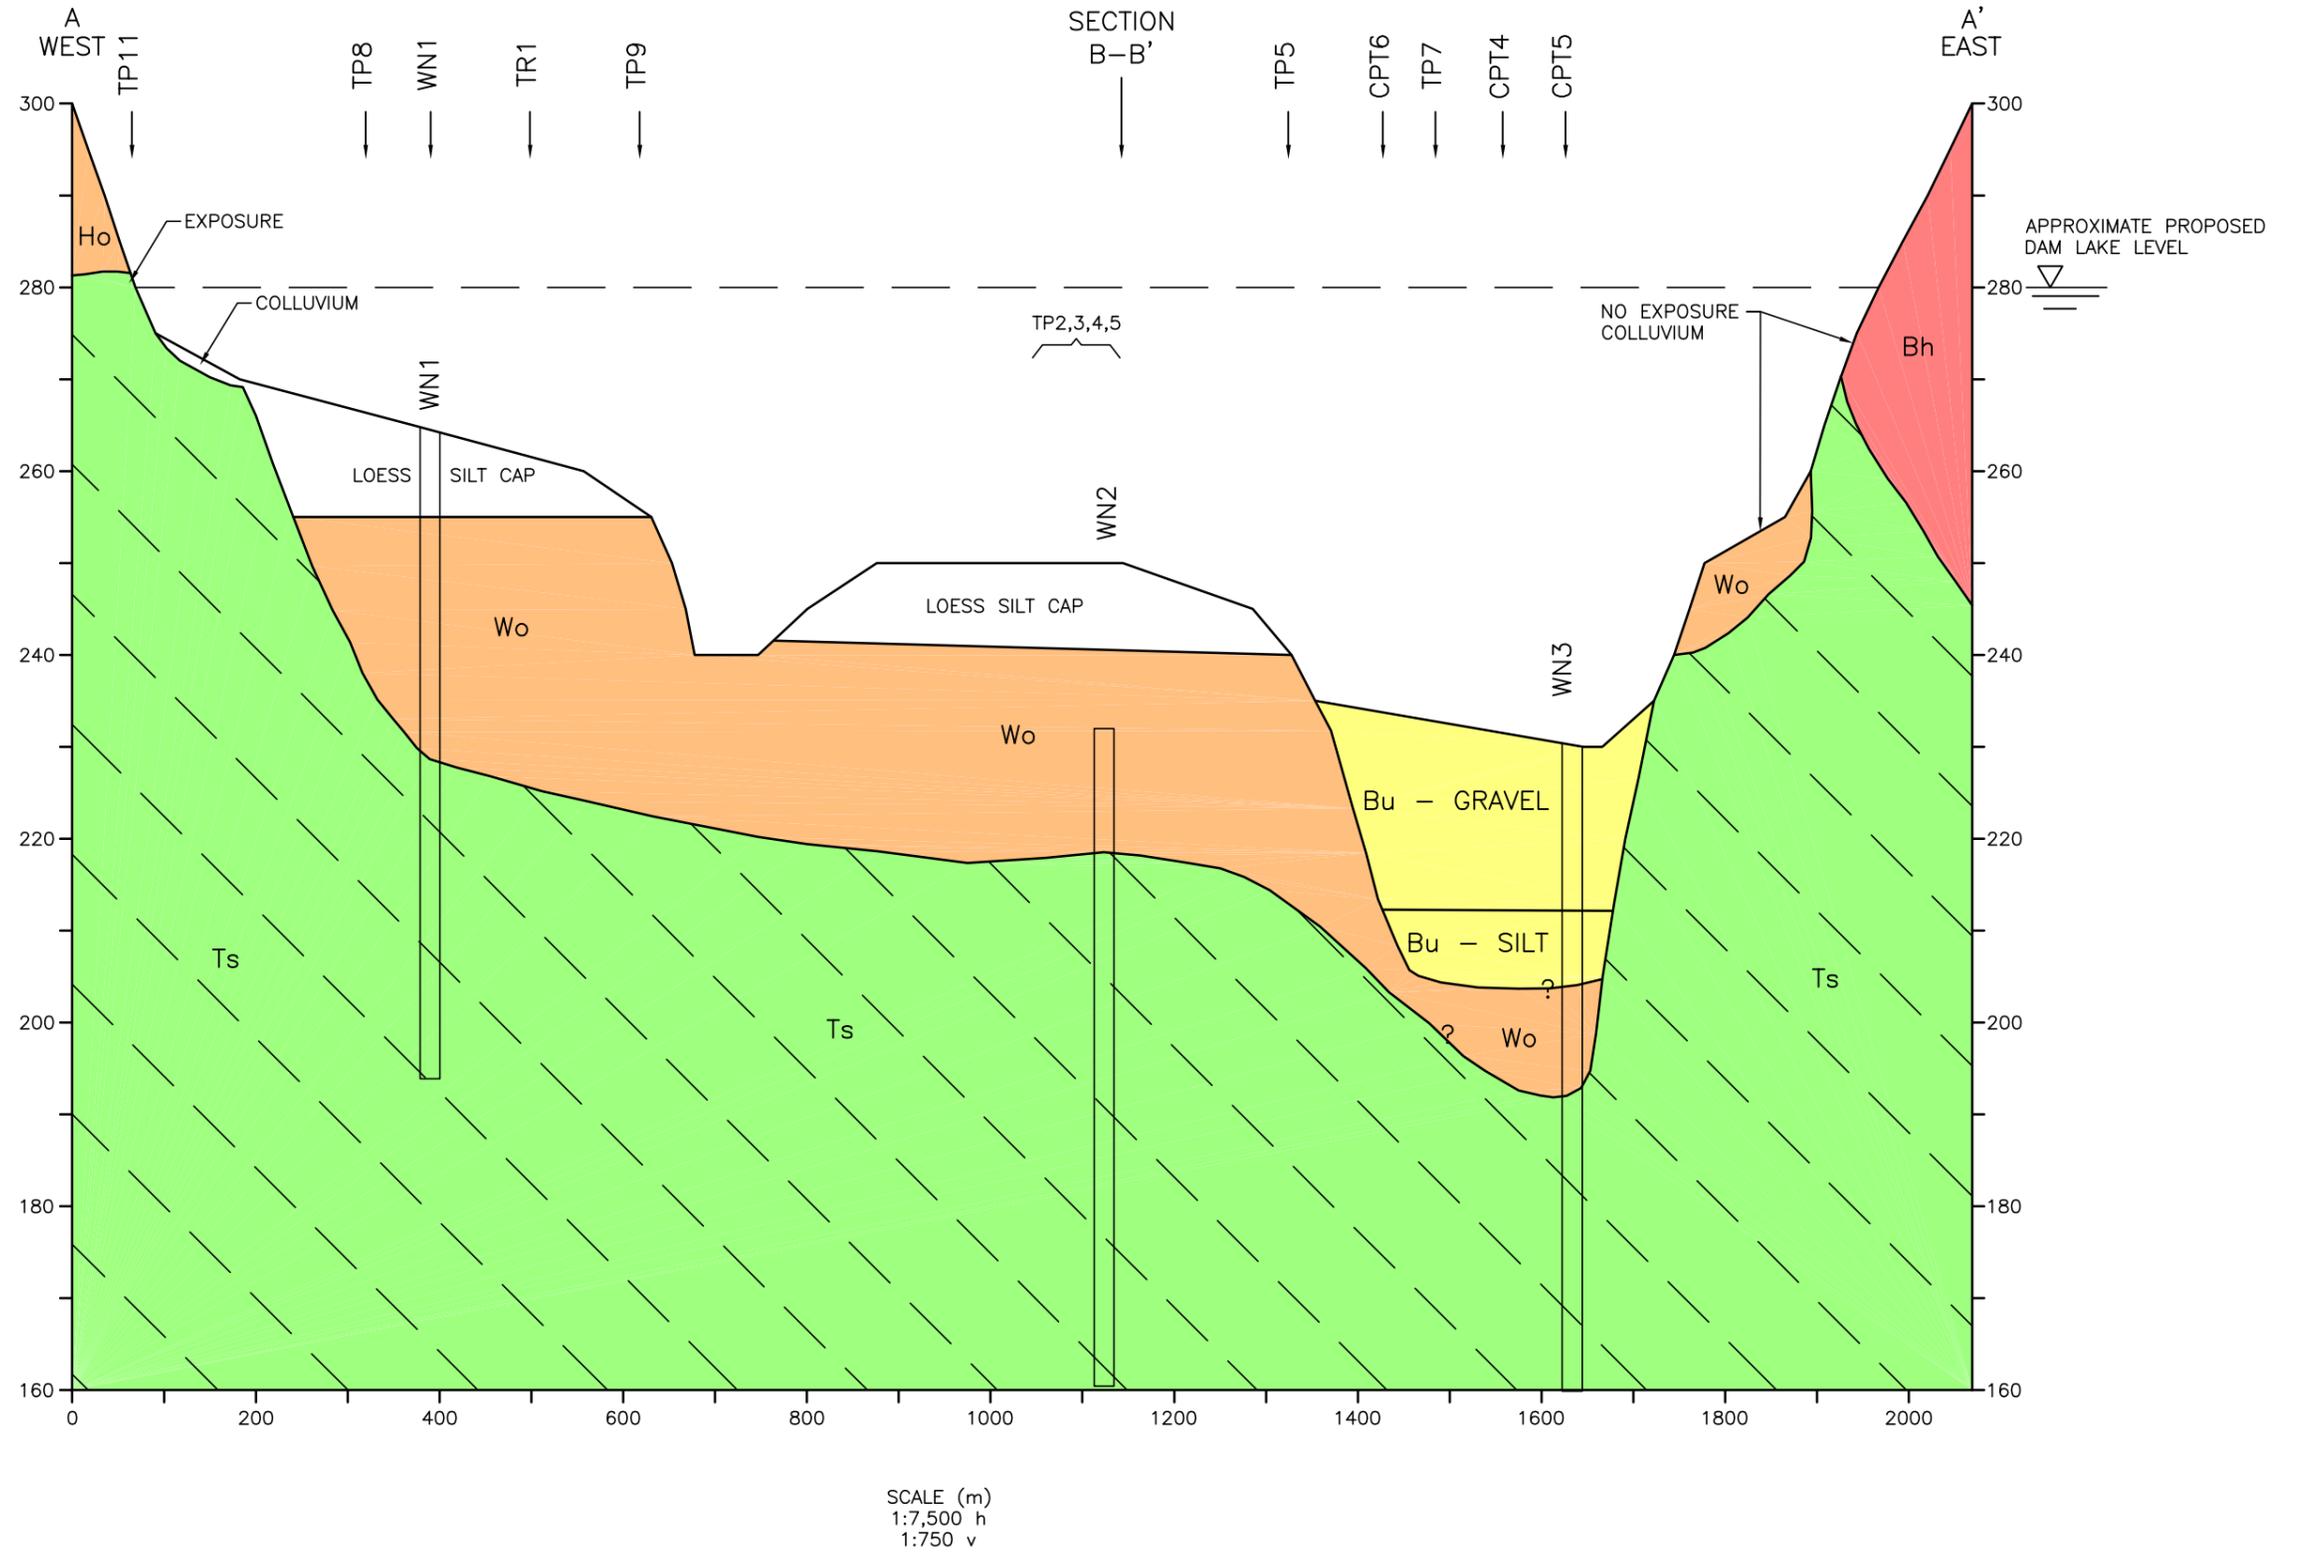
GEOLOGICAL CROSS SECTION ALONG THE PROPOSED EMBANKMENT

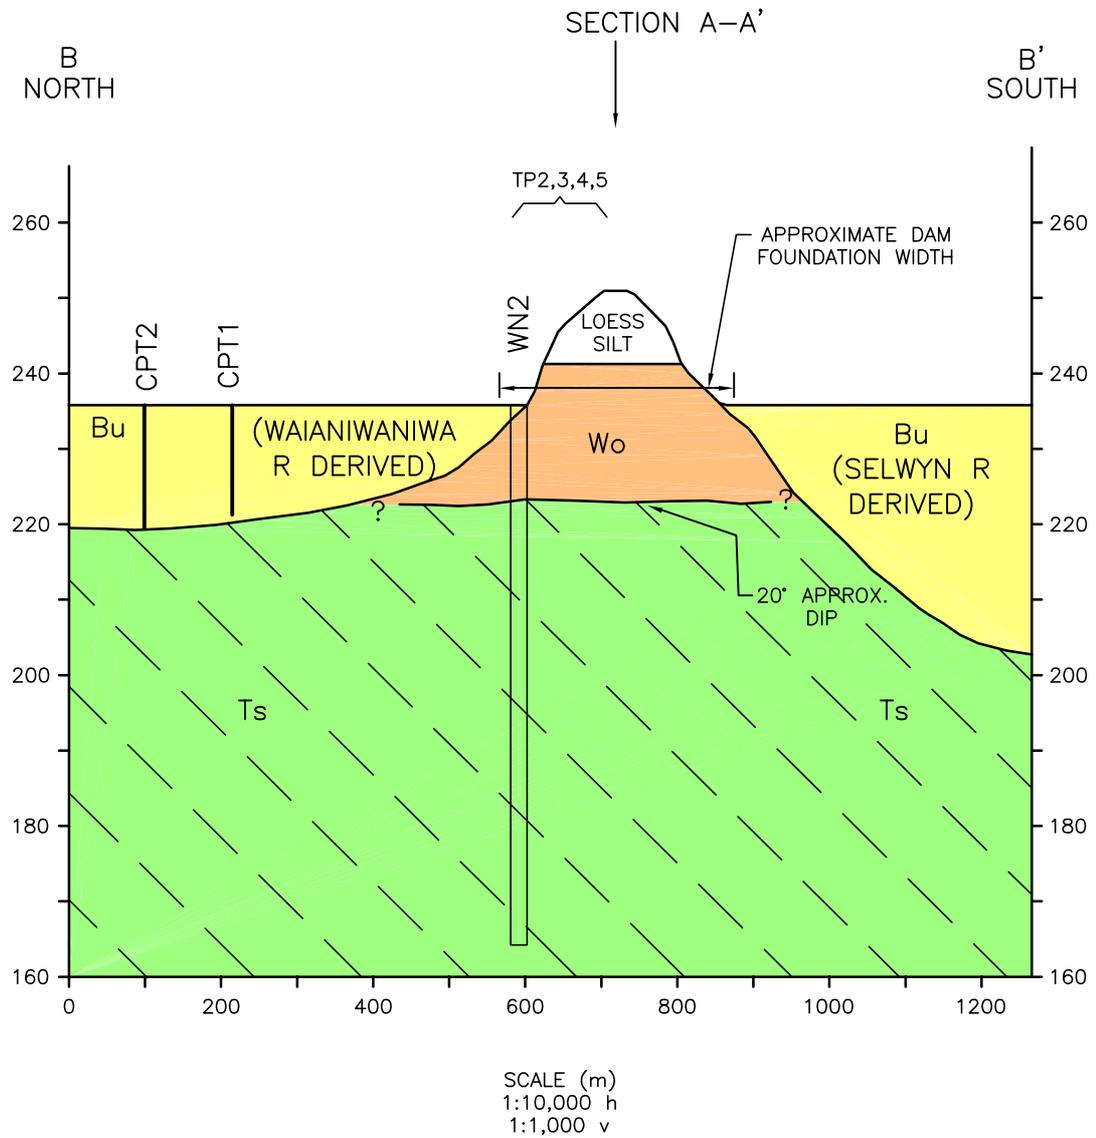
**GEOLOGICAL CROSS SECTION ACROSS
THE PROPOSED EMBANKMENT**

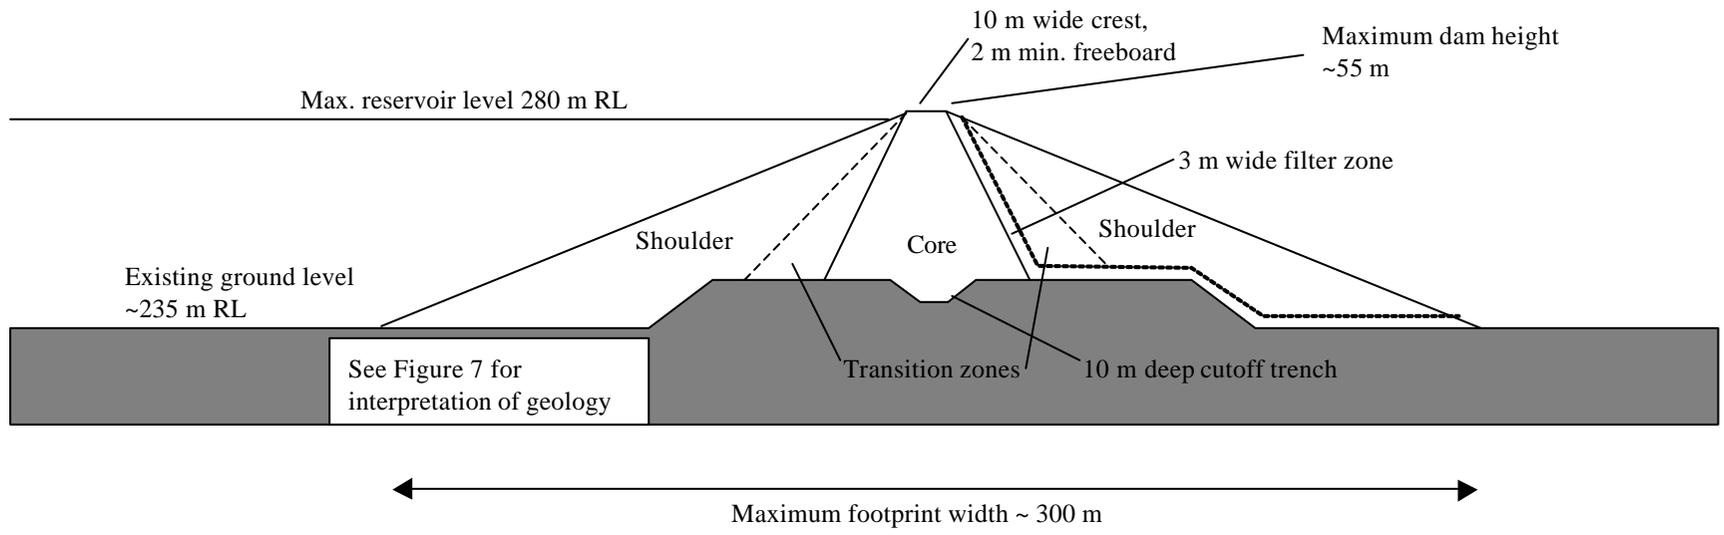
Figure 9

Conceptual embankment design for the proposed Waianiwaniwa storage dam

The conceptual design requires that the loess cap is removed from the 270 m terrace (a depth of about 10 m). Elsewhere the design adopts a foundation level three metres below existing ground level. A cut off system has been included to prevent excessive flow through the gravels under the embankment. This cutoff incorporates a 5 m deep cutoff trench with a ten metre deep slurry trench constructed in the base of the core trench that extends to the Tertiary bedrock. At the valley mouth a deeper cutoff may be required if the lower gravels prove to be too permeable.

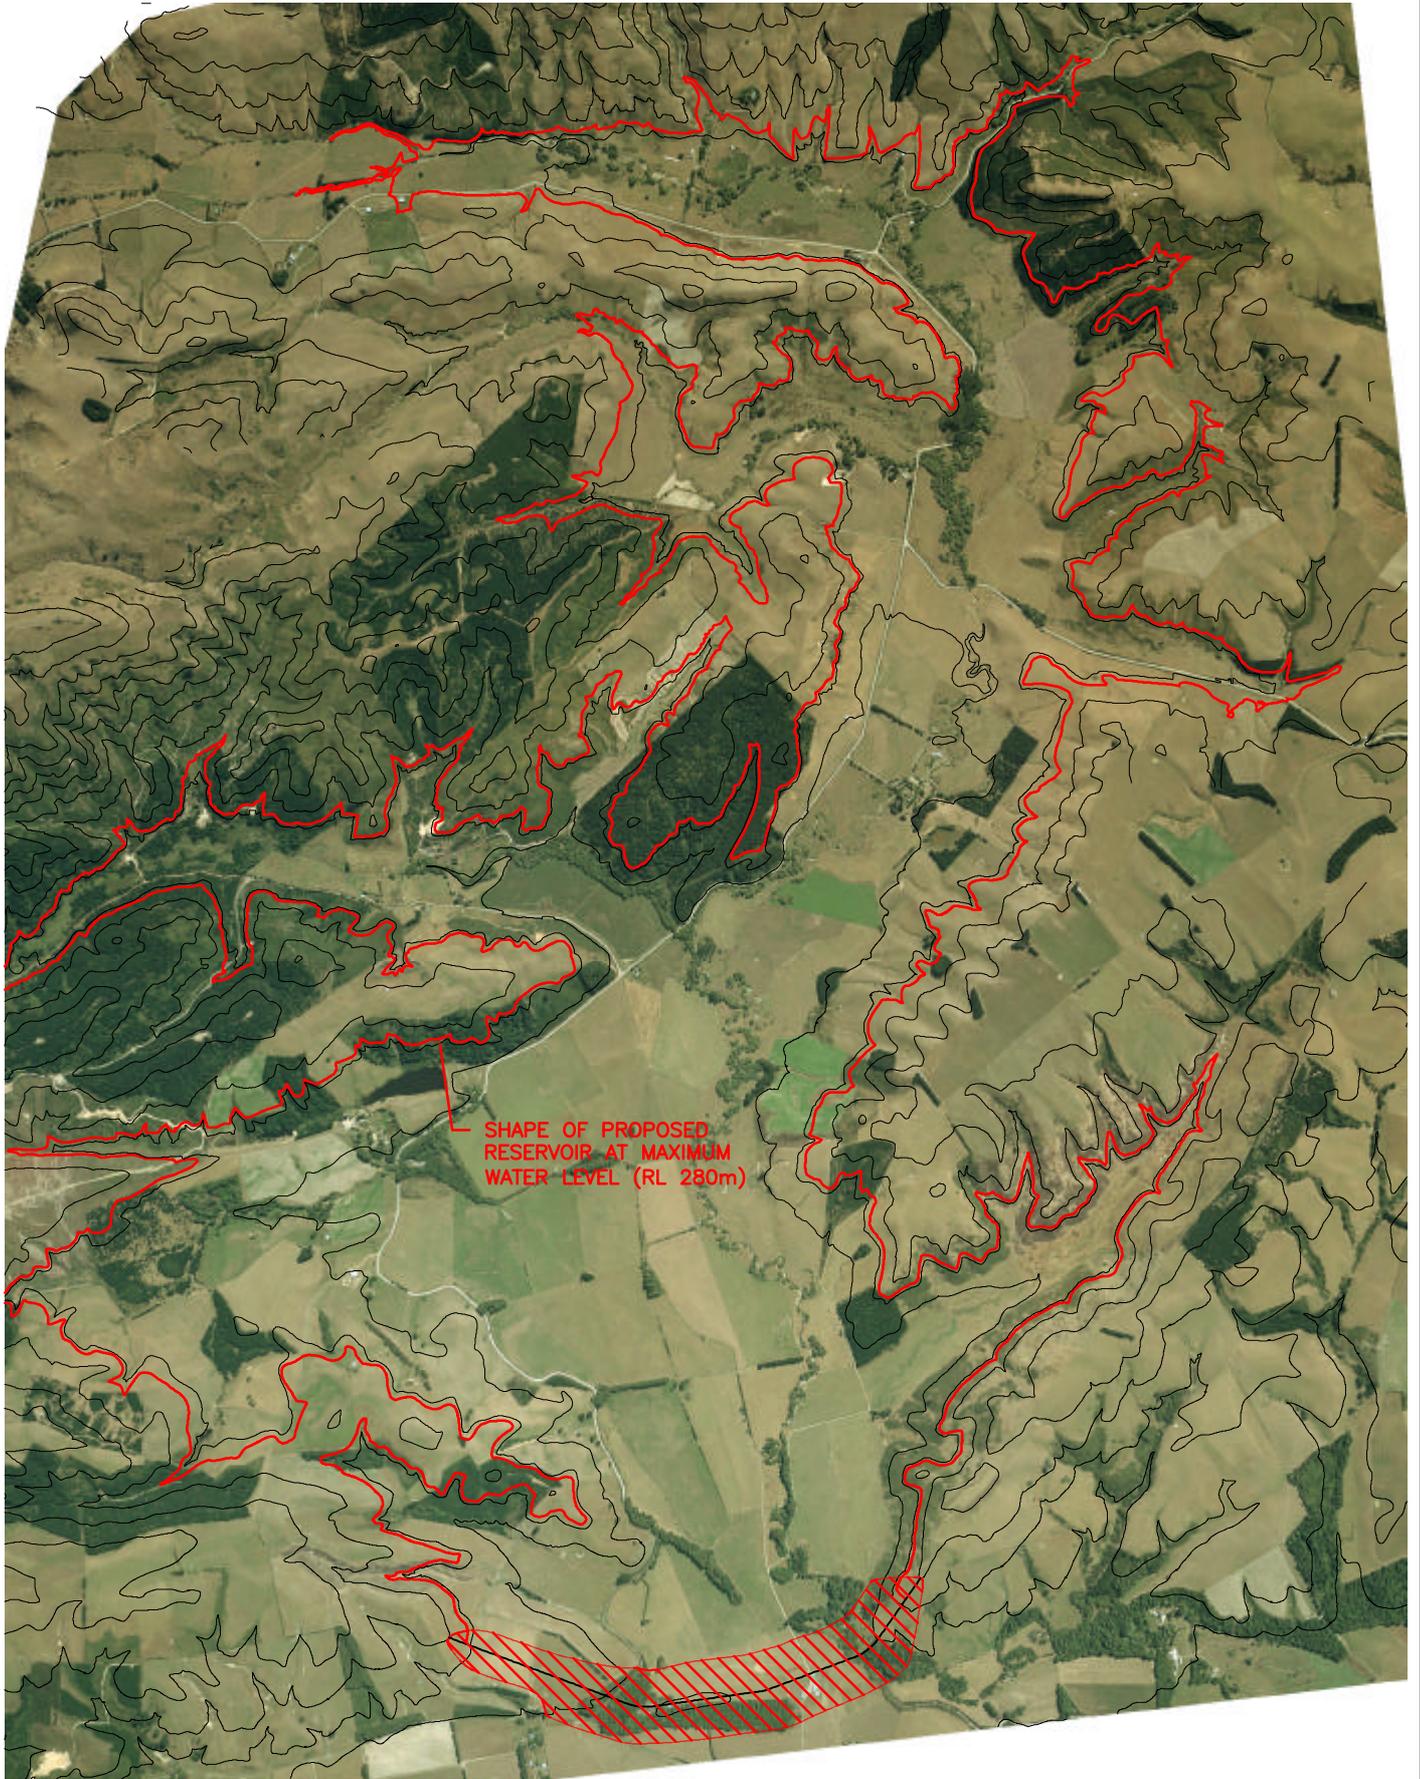
SHAPE OF PROPOSED
RESERVOIR AT MAXIMUM
WATER LEVEL (RL 280m)
