GEOTECHNICAL INVESTIGATION FOR THE PROPOSED WAIANIWANIWA WATER STORAGE DAM

Prepared for
Central Plains Water Enhancement Committee
Selwyn District Council and Christchurch City Council
c/- Private Bag 1
Leeston

11 October 2002

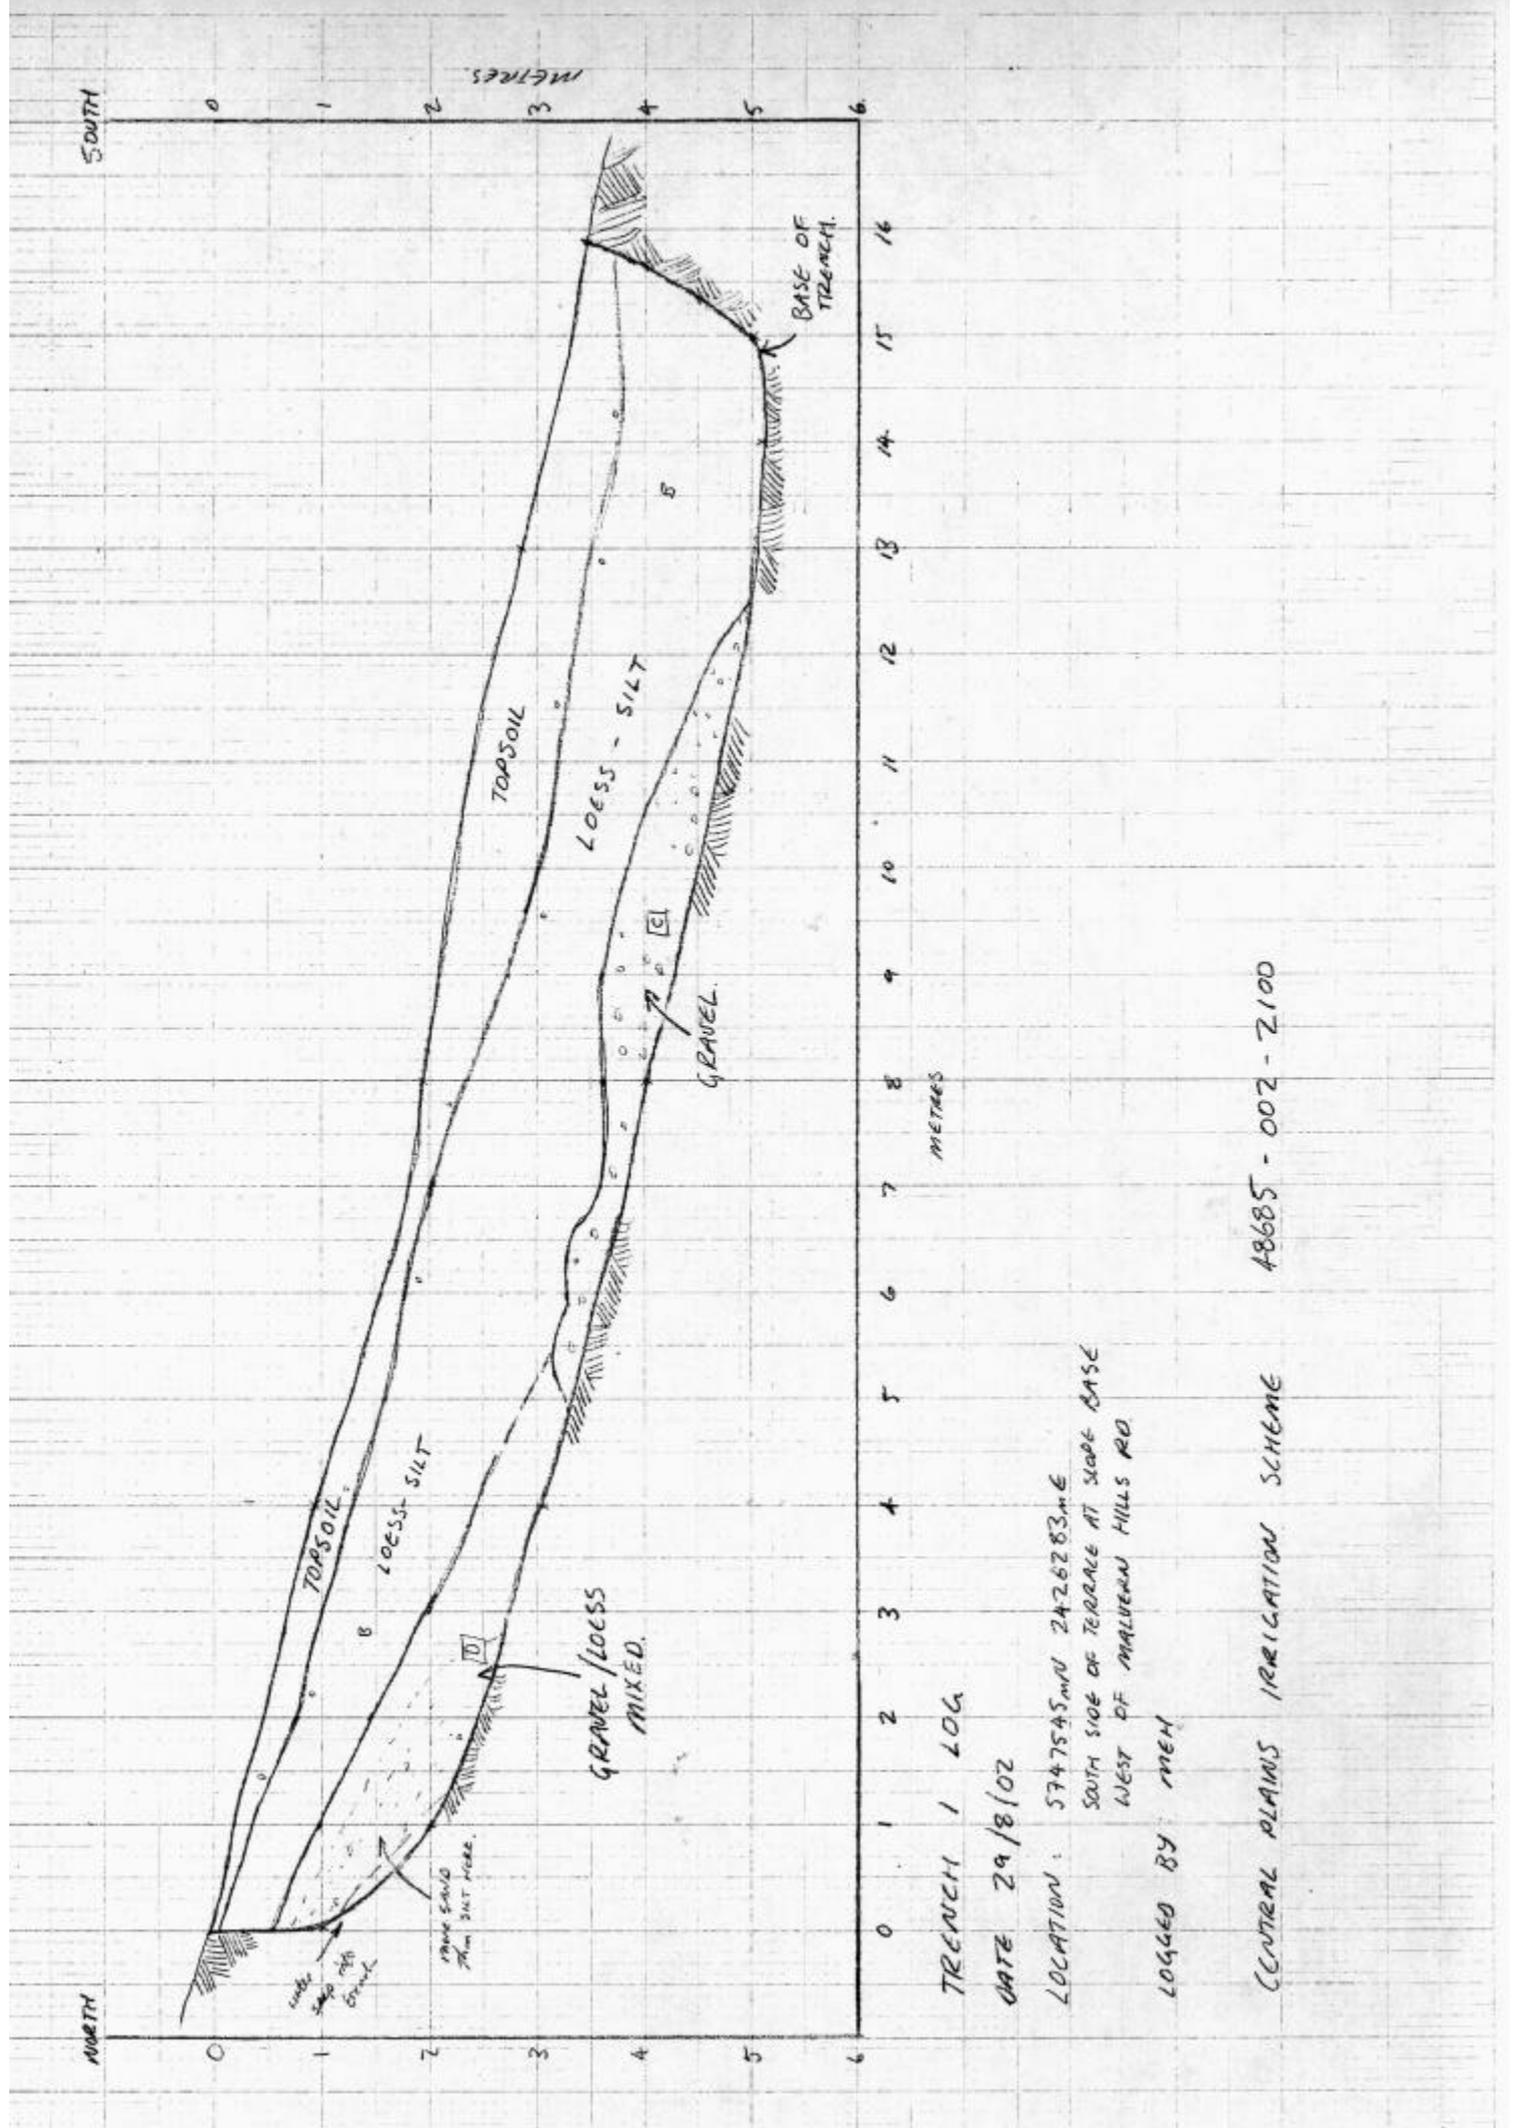
TRENCH 1 LOG

DESCRIPTION OF STRATA	GRAPHIC LOG	DEPTH (m)	GEOLOGICAL DESCRIPTION	FIELD SHEAR STRENGTH (kPa)	PENETROMETER BLOWS (N)	SAMPLING AND OTHER TESTING	GROUND WATER DATA AND COMMENTS
TOPSOIL - dark brown silt loam	(S)	0.0					
SILT - yellow brown mottled brown silt with some clay (loess or loess colluvium)	(I)	0.2					
GRAVEL - dense brown clast supported gravel, heavily stained, slightly cemented. - clasts are greywacke, highly weathered to slightly weathered, subrounded and up to 200 mm max. dimension most clasts are less than 75 mm. - some crudely bedded layers - subhorizontal	(G)	0.4	Late Pleistocene Gravels.

As described in Section 2.3.4 a linear topographic step crosses the downstream edge of the dam footprint. Trench TR1 was excavated on a steep south-facing slope west of Malvern Hills Road to look for evidence of fault-related deformation within the near surface materials. The location was chosen to avoid thick fan deposits which have formed at gully mouths along the terrace edge. Subhorizontal brown gravels were encountered in the trench underlying about 1.5 m thickness of loess and gravel colluvium. No evidence for faulting or tectonic deformation was found in TR1.

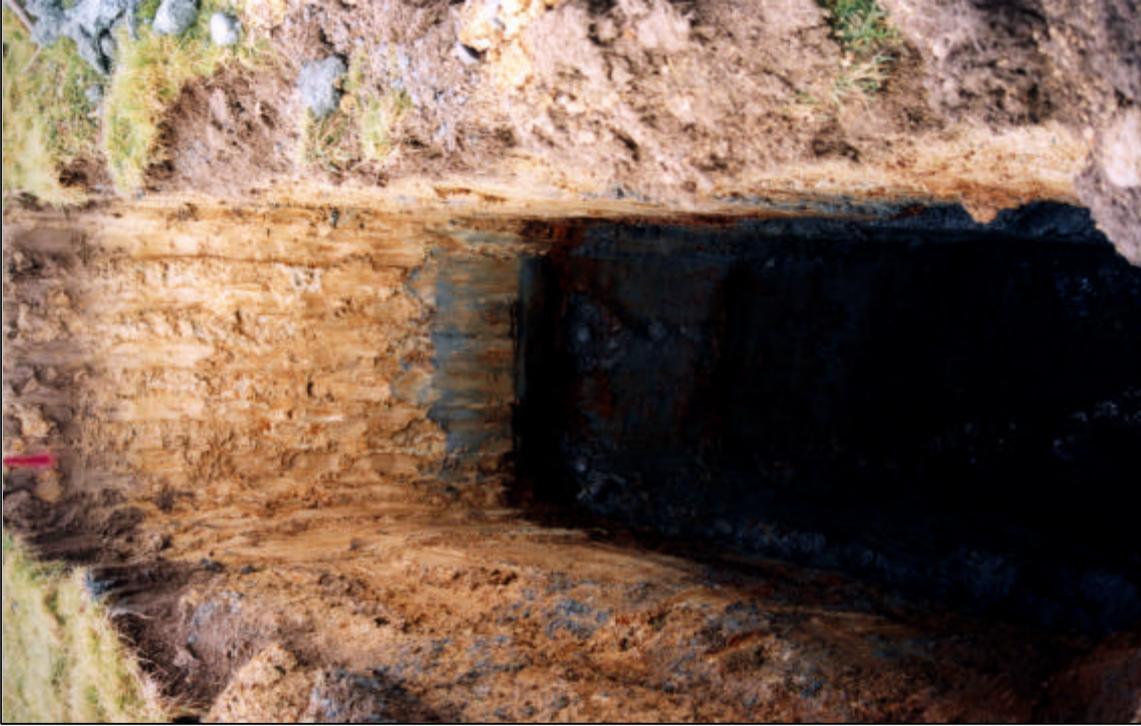
Test Pit 1 showing brown gravelly silt overlying saturated grey silts and gravels

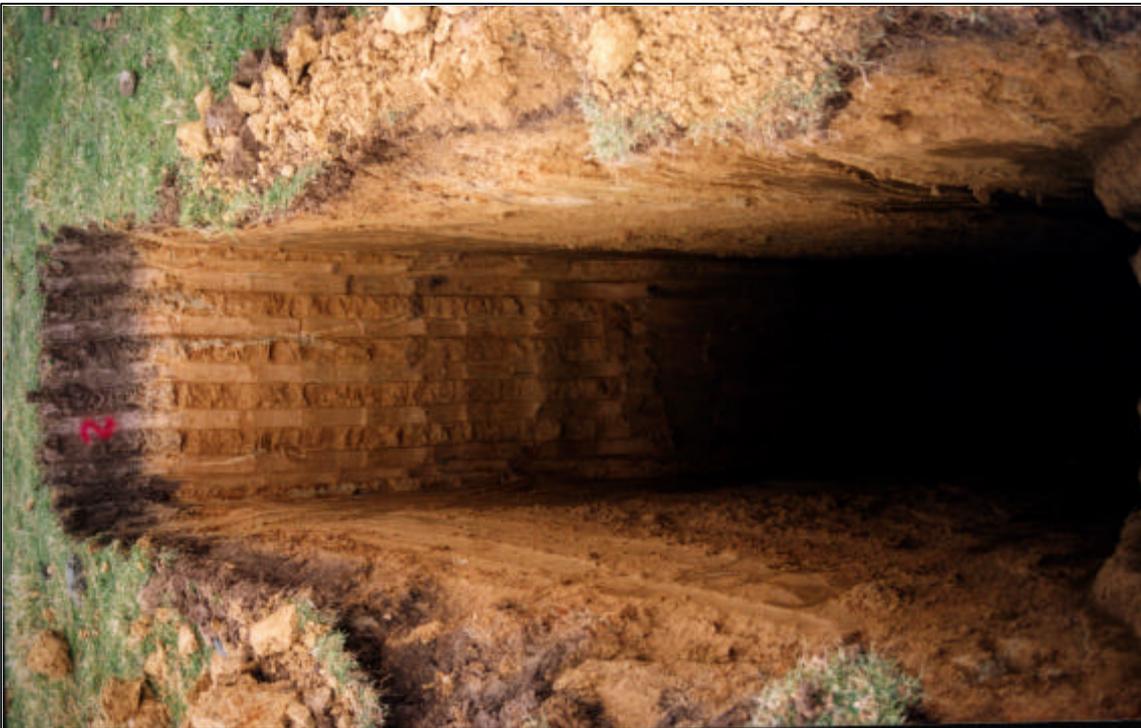
Test Pit 2 showing yellow brown loess to full depth of excavation

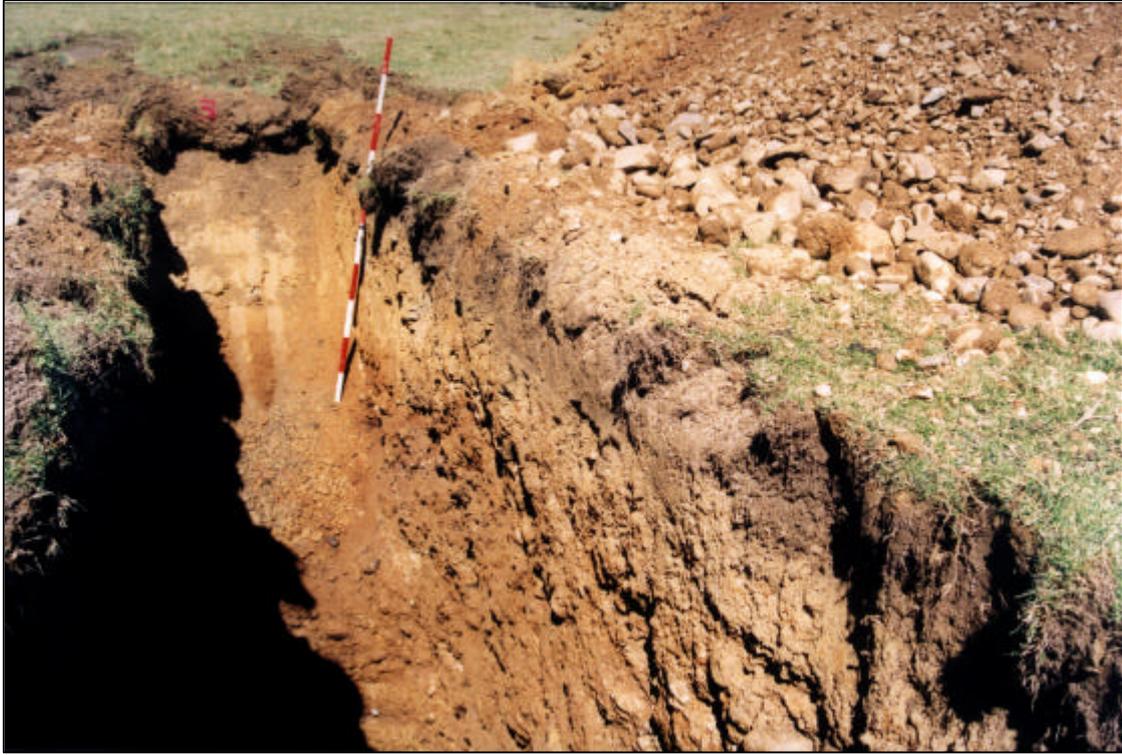
Test Pit 3 showing yellow brown loess overlying grey brown gravels. Loess thickens upslope.

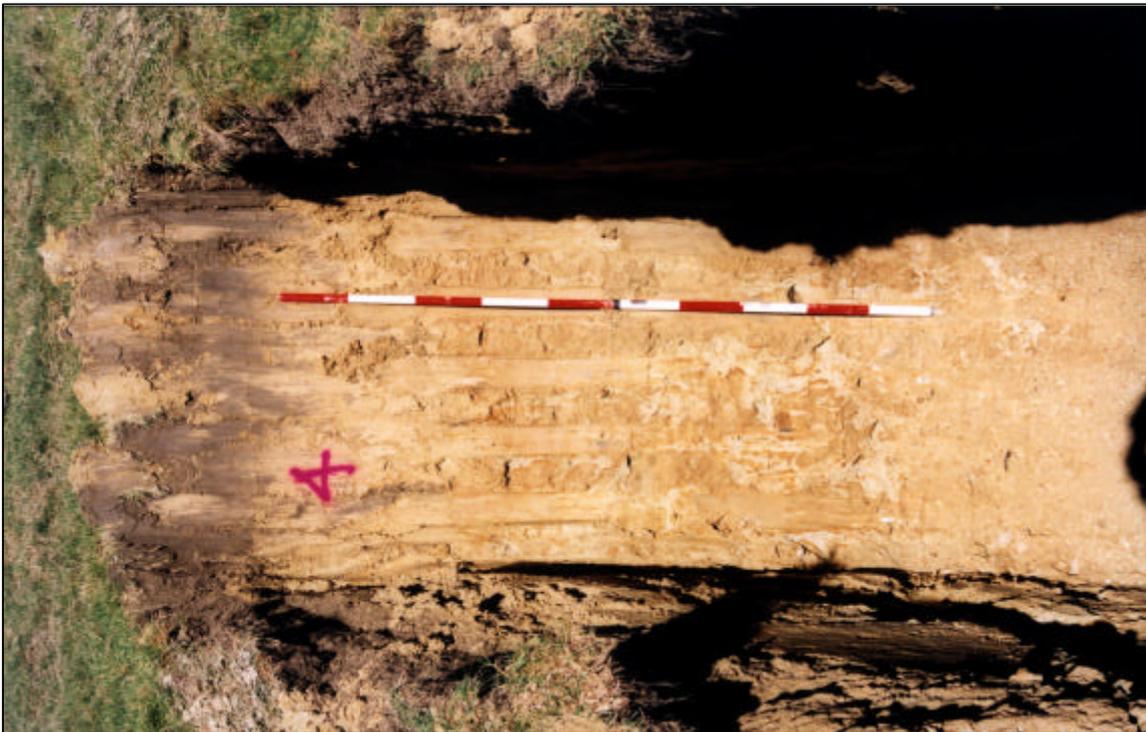
Test Pit 4 showing yellow brown loess colluvium containing rare gravel clasts overlying gravel.

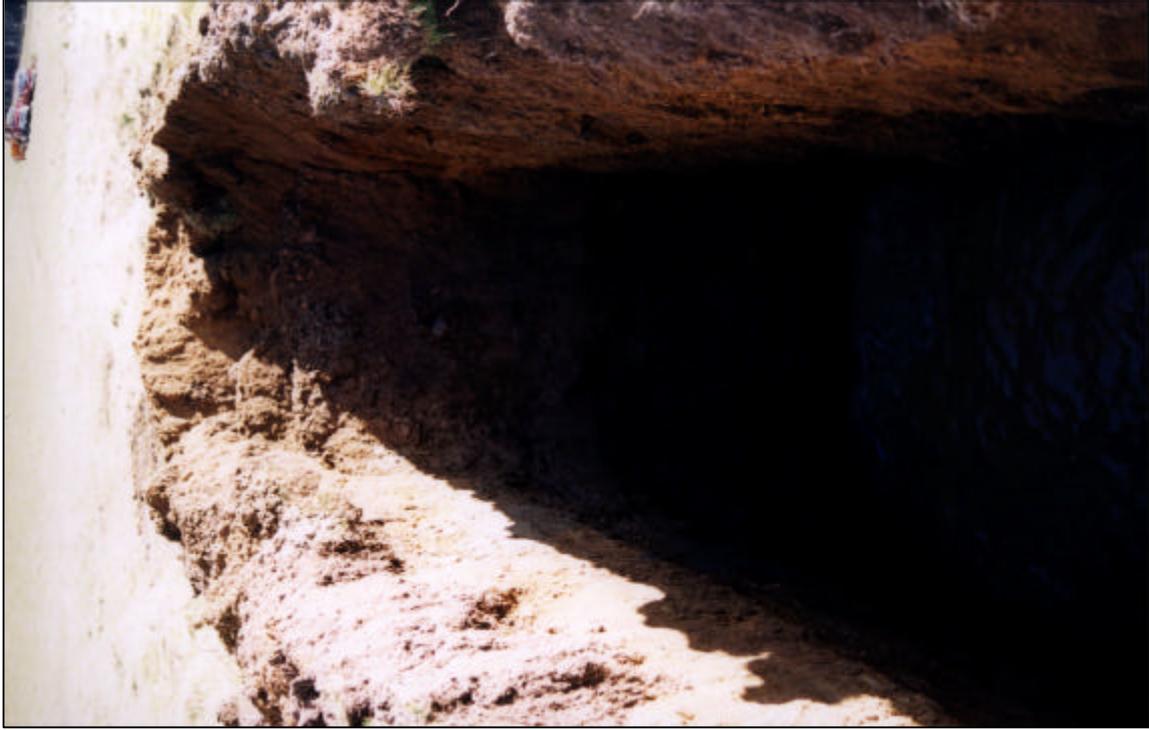
Test Pit 5 showing interbedded sand, silt and pebbly gravel. Water table is at about 2 m depth.

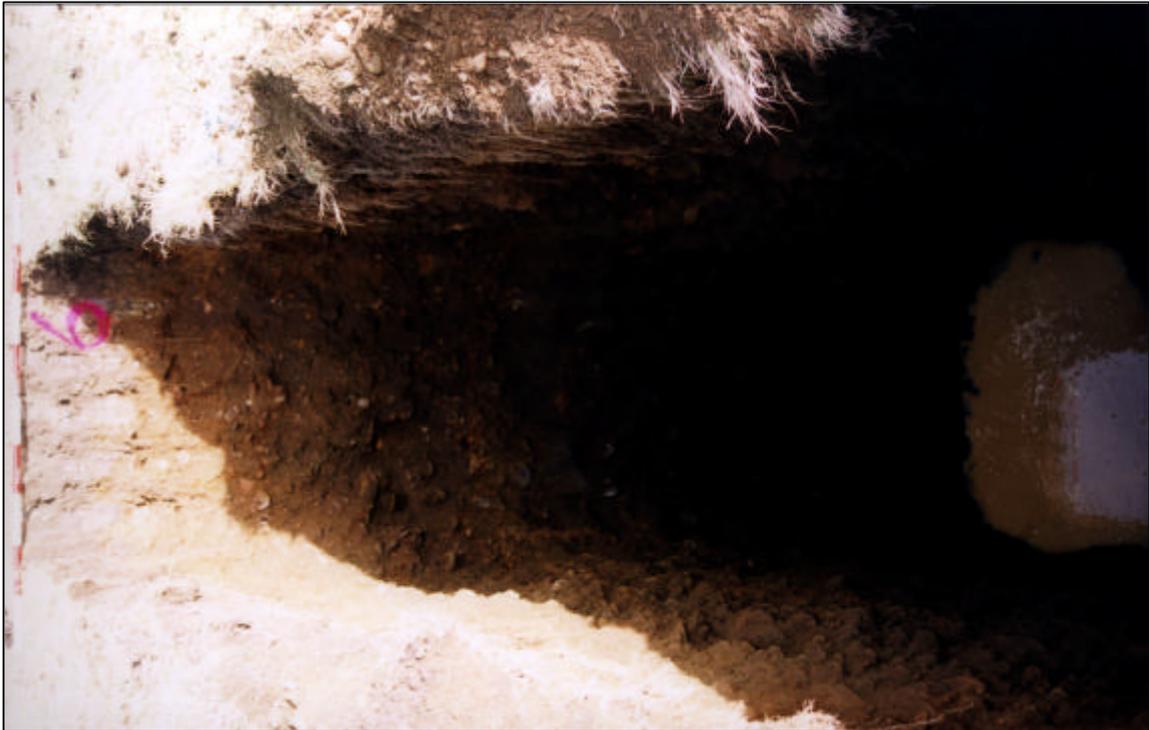
Test Pit 6 showing yellow brown silty gravel. Water table is at about 4 m

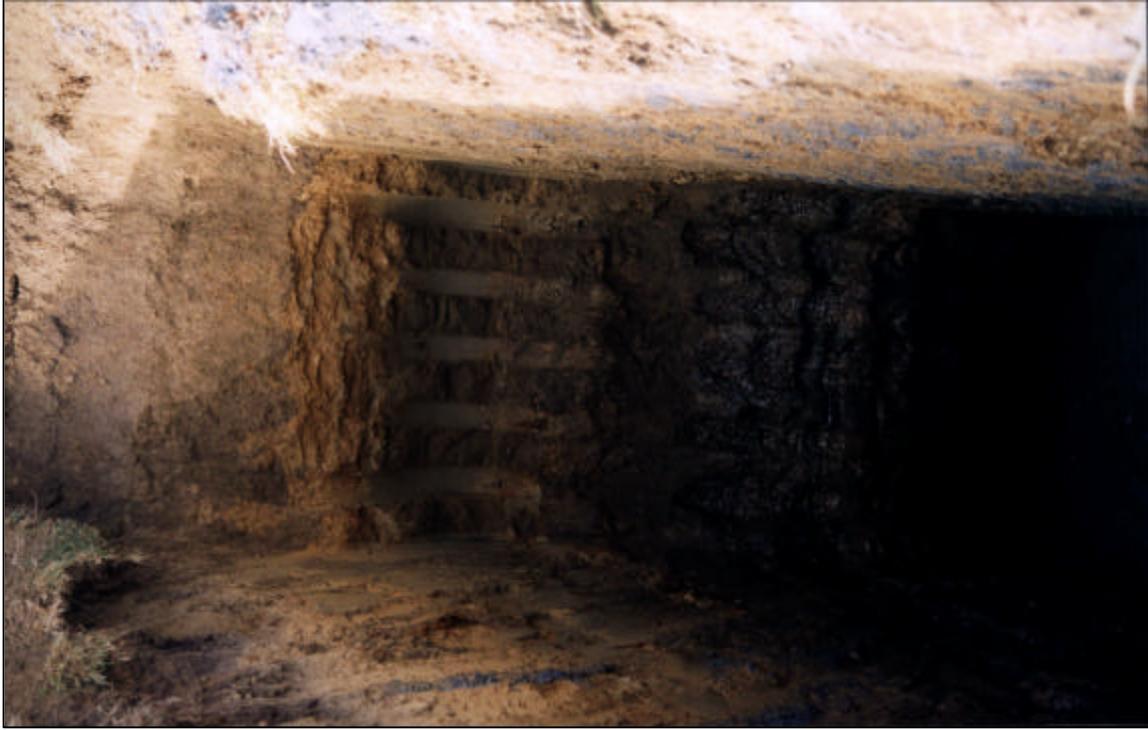
Test Pit 7 showing interbedded sand, silt and pebbly gravel. Water table is at about 4 m depth.

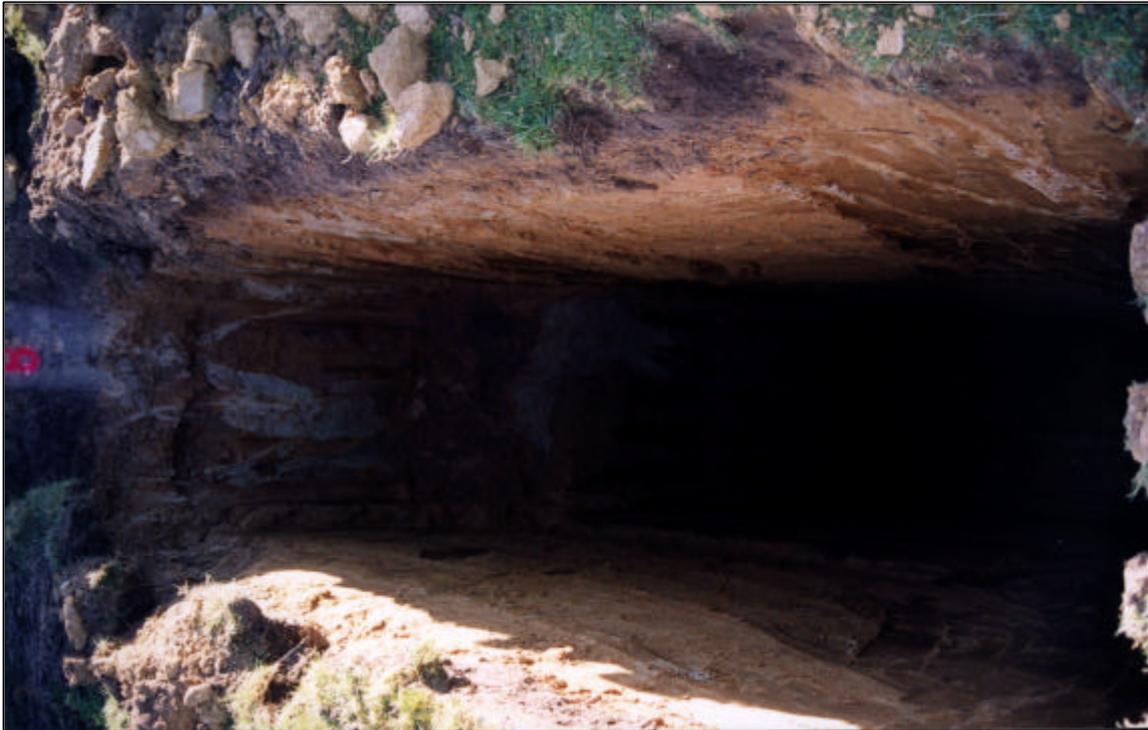
Test Pit 8 showing yellow brown loess to the full excavation depth of about 6 m.

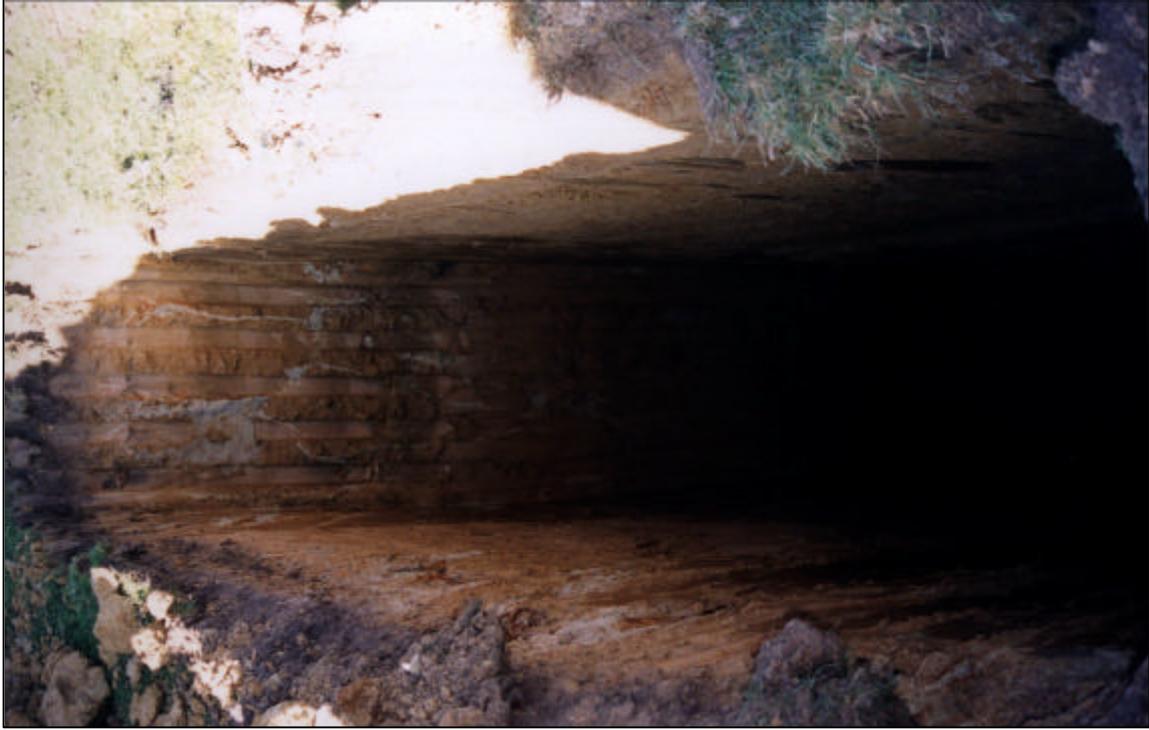
Test Pit 9 showing yellow brown loess to the full excavation depth of about 5.5 m.

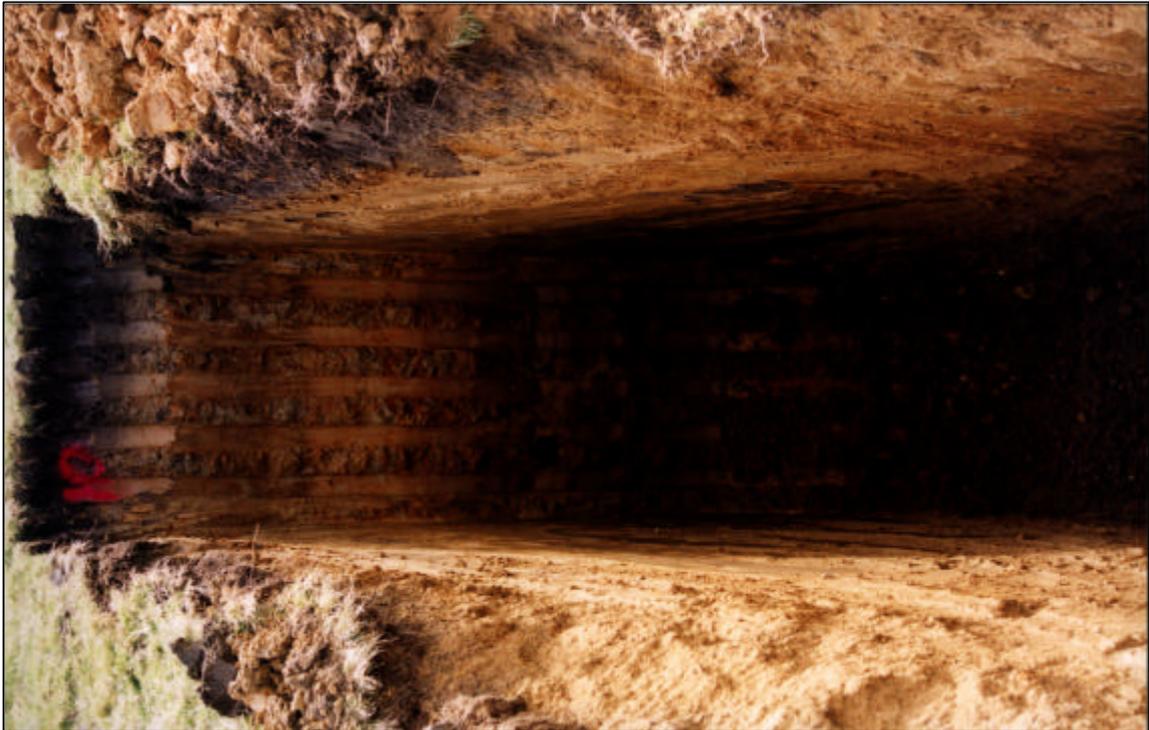
Test Pit 10 showing yellow brown loess overlying weathered gravel at about 3 m depth.

The **right abutment** of the proposed dam will be formed against a terrace with a surface elevation of about RL320 m. Test pit 10 was excavated in the upper terrace surface and encountered 3 m of weathered very stiff to hard yellow brown sandy silty loess overlying highly weathered brown greywacke gravels. Test pit 11 was excavated on a spring line at about elevation RL280 m and it encountered gravelly colluvium and in situ weathered gravel to a depth of 2 m overlying very weak sandstone. Seepage was observed entering the pit at the base of the colluvium. The permeability contrast between outwash gravels and underlying Tertiary sediments is inferred to result in the spring line, which crosses the right abutment at about RL280 m.

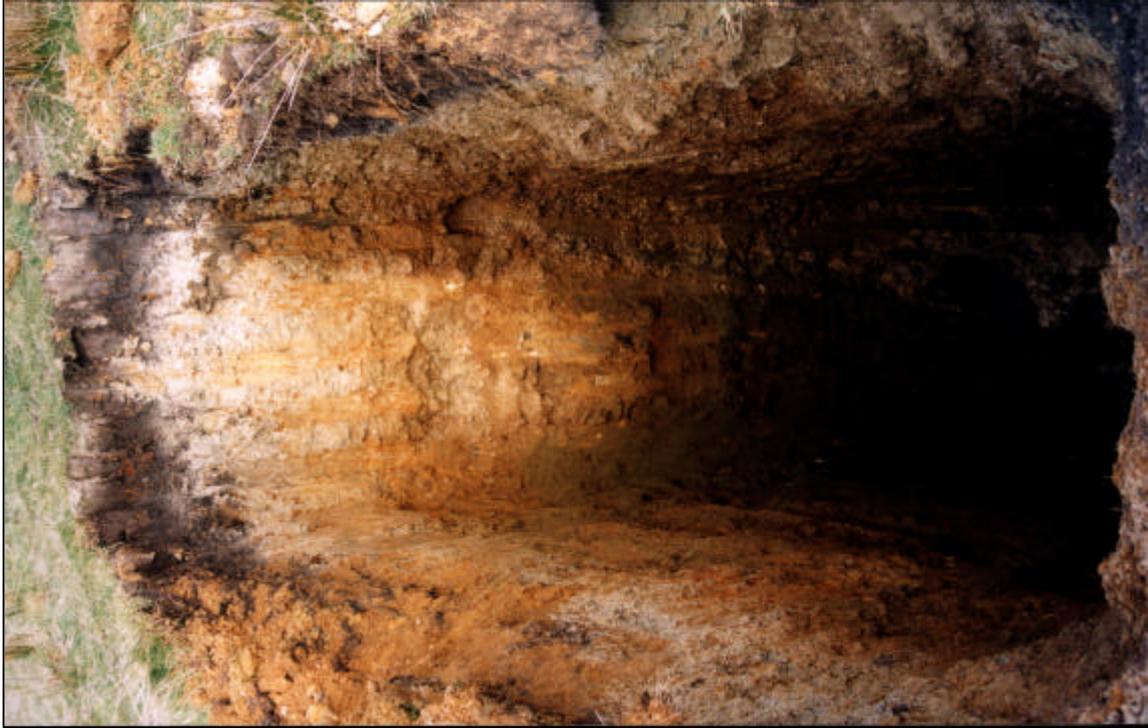
Test Pit 11 showing yellow brown silty gravel colluvium overlying grey sandstone at about 3.0 m.

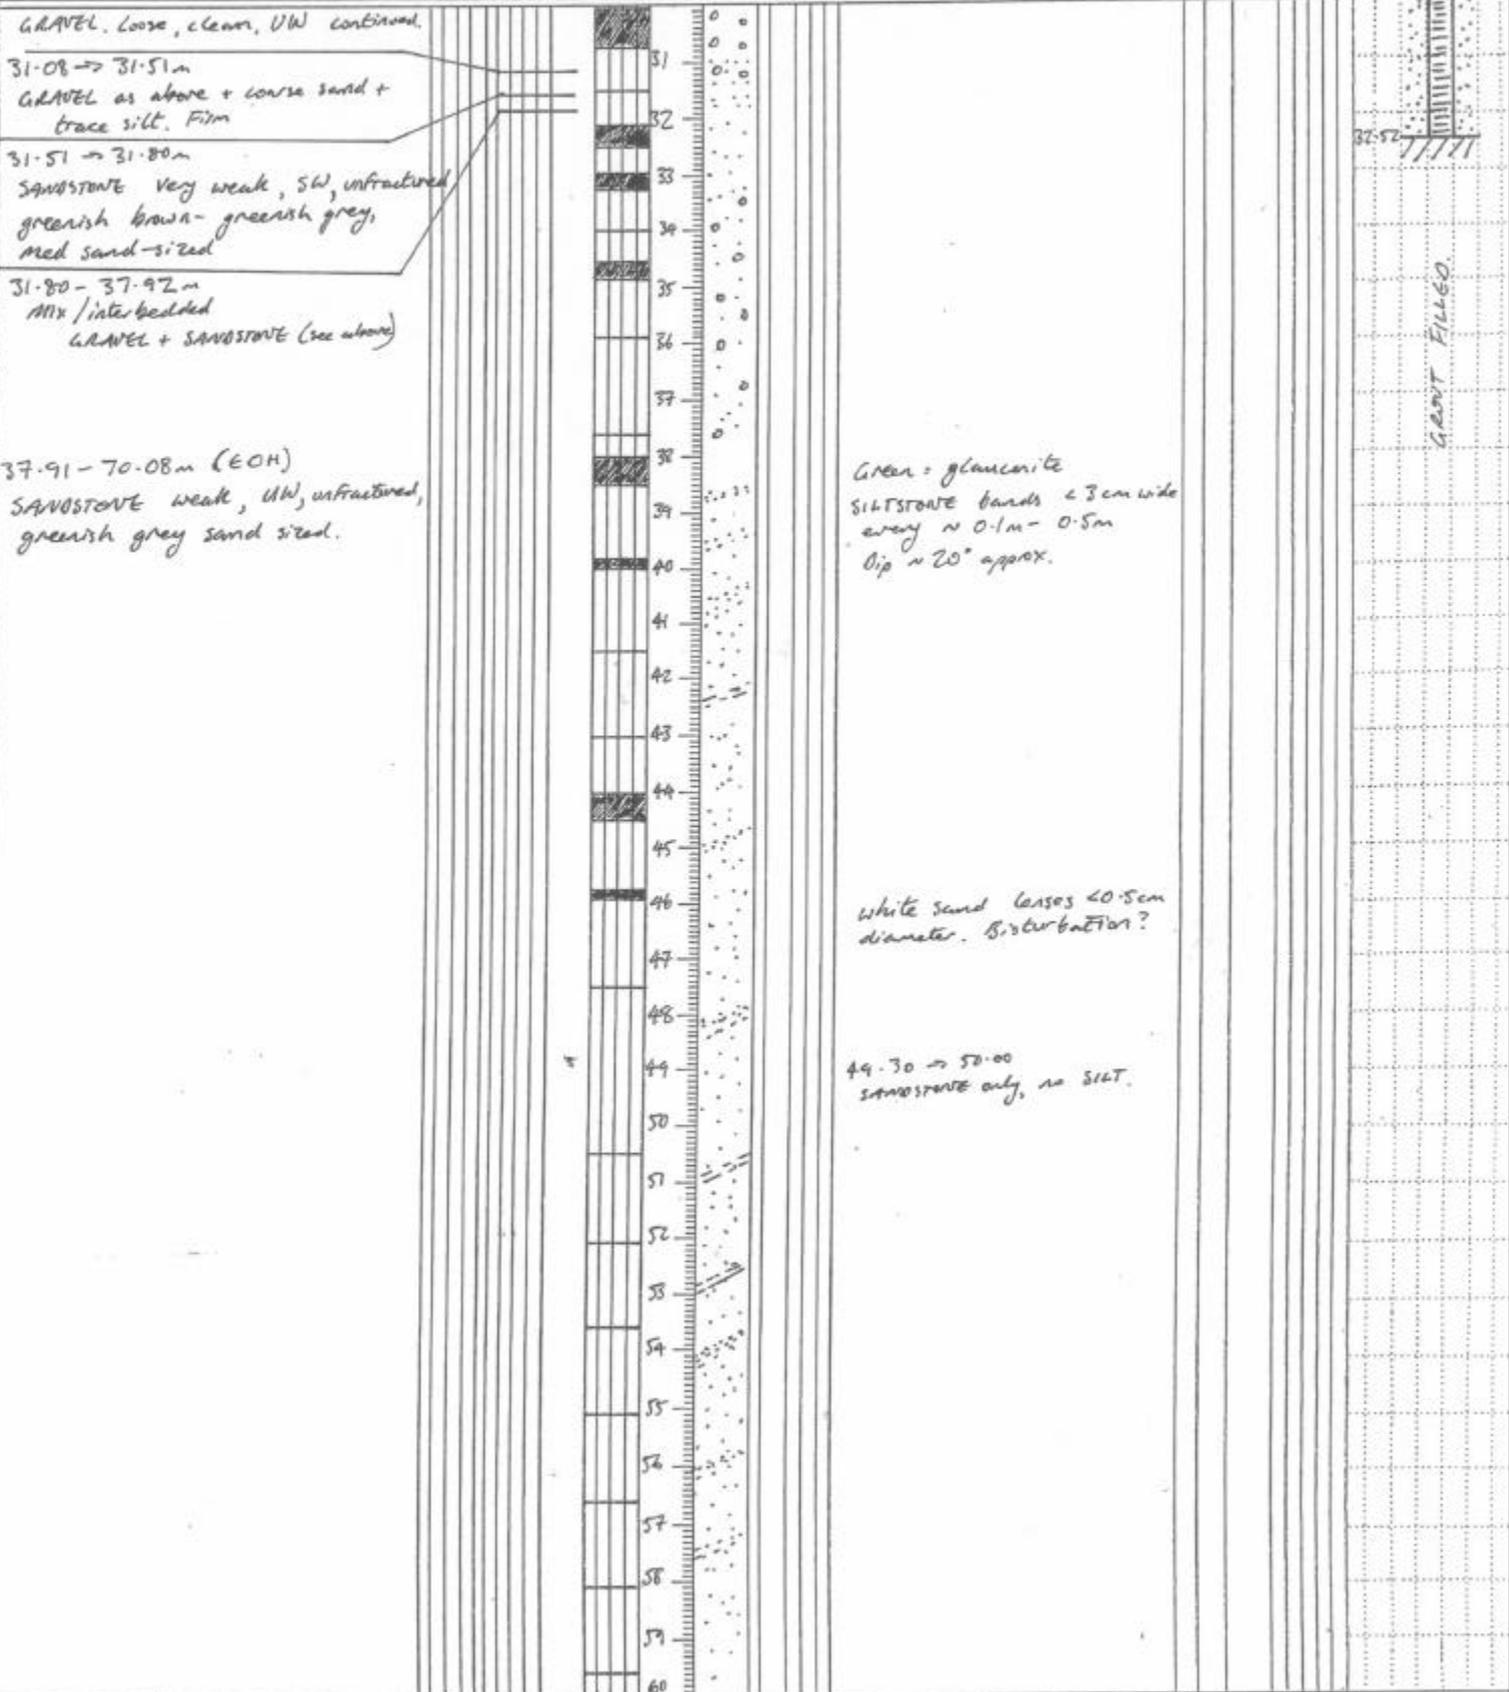
LOG OF DRILL HOLE

PROJECT 48685-002-2100 FEATURE LAIANIWAHWA DAM LOCATION CENTRAL PLAINS WATER
 GRID REF. NZMG CO-ORD. 574763.73mN 2427467.08mE DATUM LINZ (MSL)
 ANGLE FROM HORIZONTAL VERTICAL DIRECTION NA H.A.D. GROUND 231.20m H.A.D. COLLAR 231.20m

Drillhole WN3 encountered greywacke dominated gravels to a depth of 18 m. Gravel clasts were typically slightly weathered, brown or black stained on the outside. This sequence included a sandy silt layer at about 5.8 to 8 m depth (drillhole log is presented in Appendix C).

Between 17 and 18 m depth, volcanic clasts were noted within the gravels. Between 18 and 27 m depth grey very stiff silt and very fine sand was encountered. This was laminated in part with typical lamination thickness of less than a few mm. Pocket penetrometer strength measurements were undertaken with most results falling in the range of very stiff to hard (Figure 8). Between 27 m and 38 m depth further gravels

Rock was encountered between 38 m and 70 m depth, giving a rockhead elevation of about RL200. The rock comprised very weak silty fine grained slightly glauconitic sandstones, greenish grey in colour. The bedding is typically dipping at about 15° but dip direction of bedding could not be measured as the core was not orientated. Joints were absent in the core, probably as a result of its relatively low strength, and the core was unweathered.
